# **COMBE MILL**

## **Building Condition Report**

**August 2023**

Prepared for Combe Mill Society by Tony Simmons

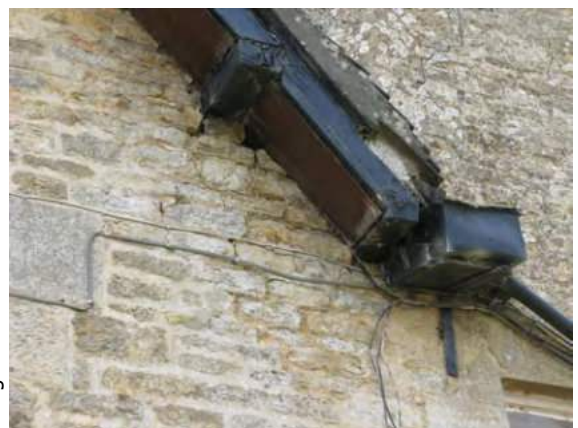
Image 4220A

Rotten timber in edge of front roof and cracks in rubble wall

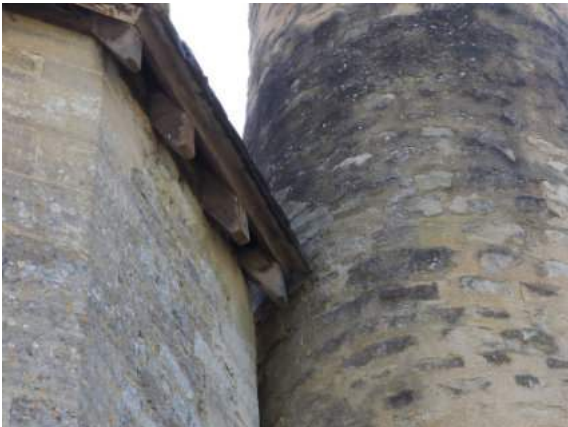
Image P524008.jpg

**Repaired turret roof against chimney**

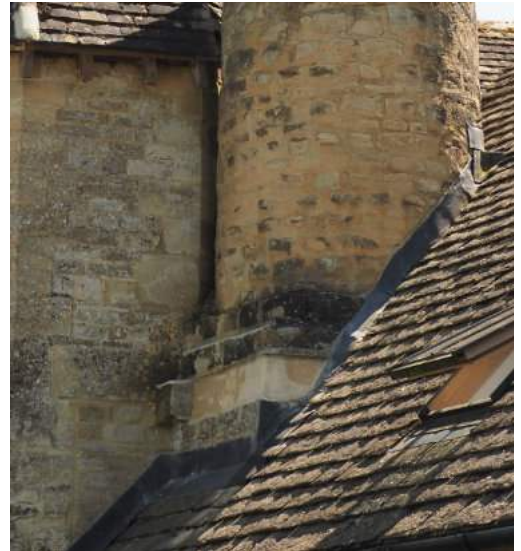
Image P524004.jpg

**Repaired stonework at chimney base**

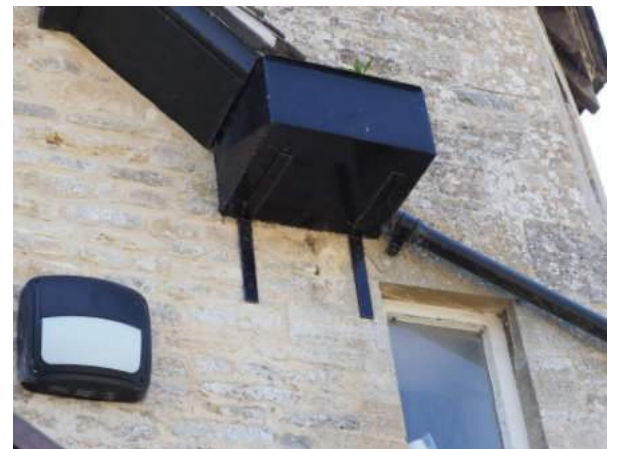
Image P524008.jpg

**Replaced rainwater tundish**

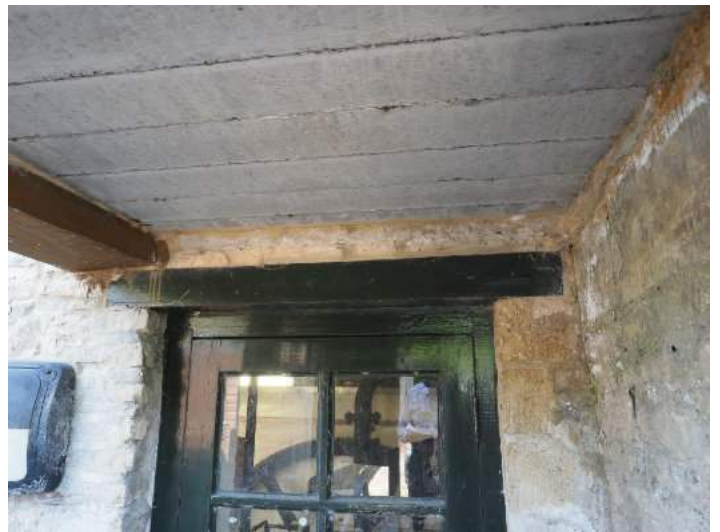
Image P524015.jpg

**Repaired outside stairs landing**

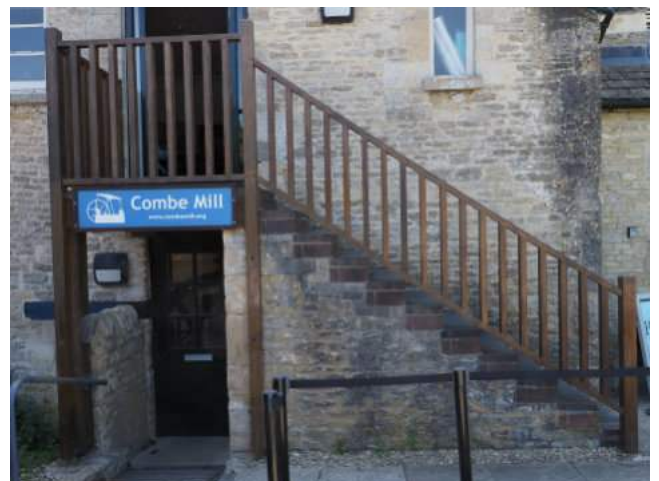
Image P524012.jpg

**Rebuilt outside stairs railings**

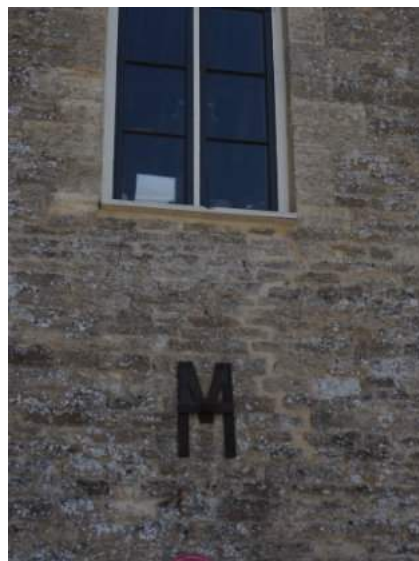
Image P524021.jpg

**Repaired ground floor windows**

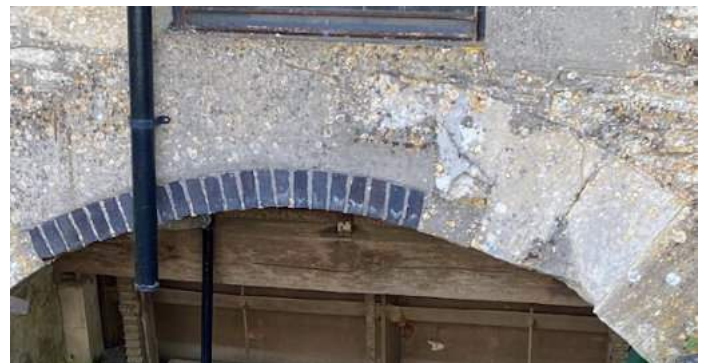
Image IMG\_1336.jpg

**Headrace arch - slight indication of masonry crack being monitored**

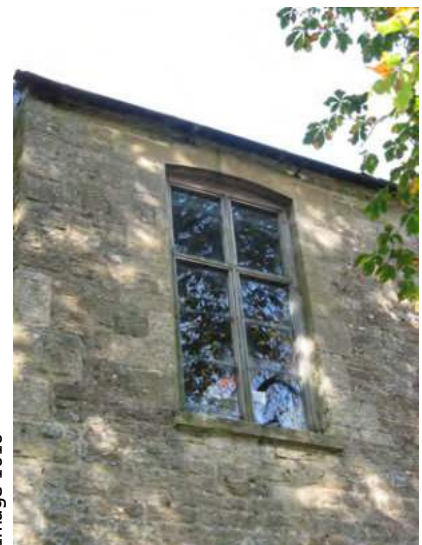
Image 1616

Series of images showing lack of guttering, broken stone window lintels and cracks in rubble wall

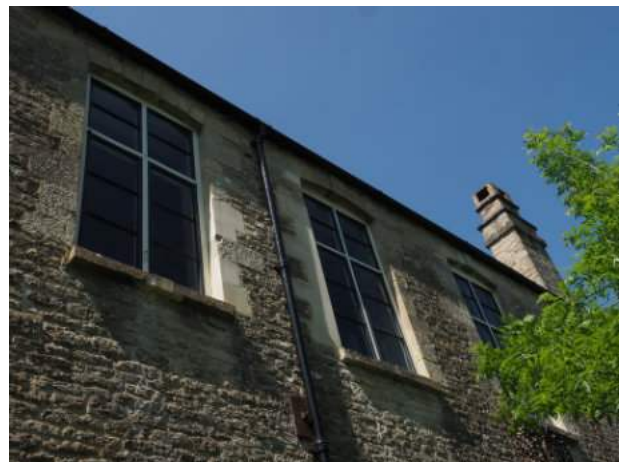
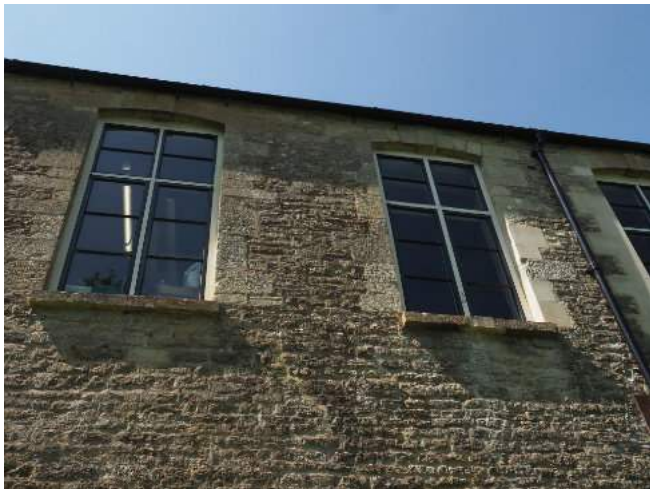
**Series of images showing added guttering, repaired stone window lintels and repairs to rubble wall  
Chimney height raised to above roof crest to stop smoke in forge**

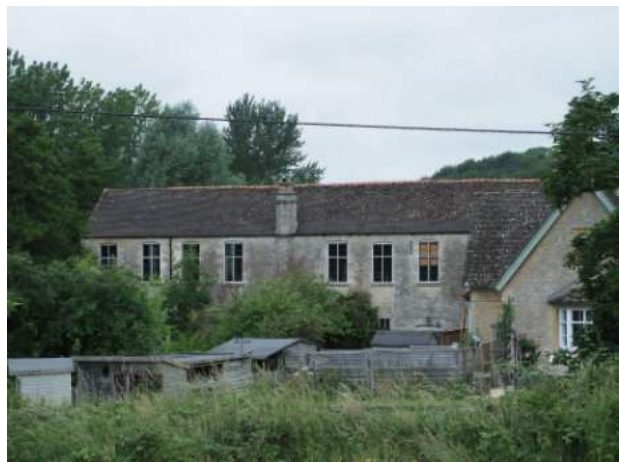
Image P6280201.jpg

**Field view of Mill showing tile coverage and absence of old slates on left hand face. All windows are new.**

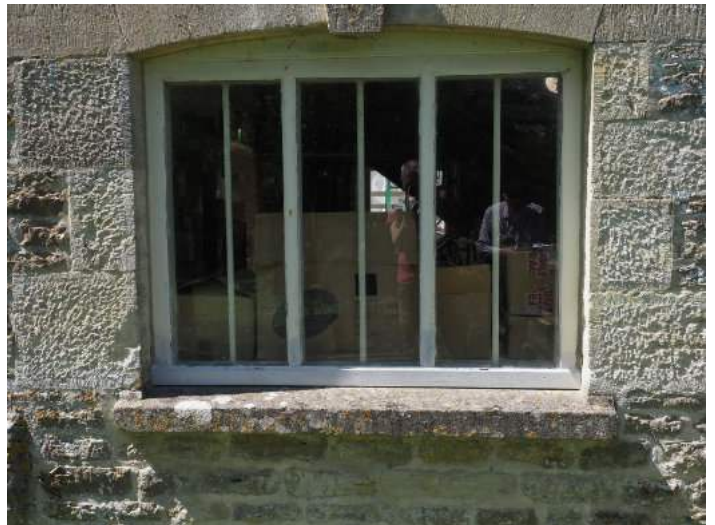
Image P5240046.jpg

## Repaired lintel and sills

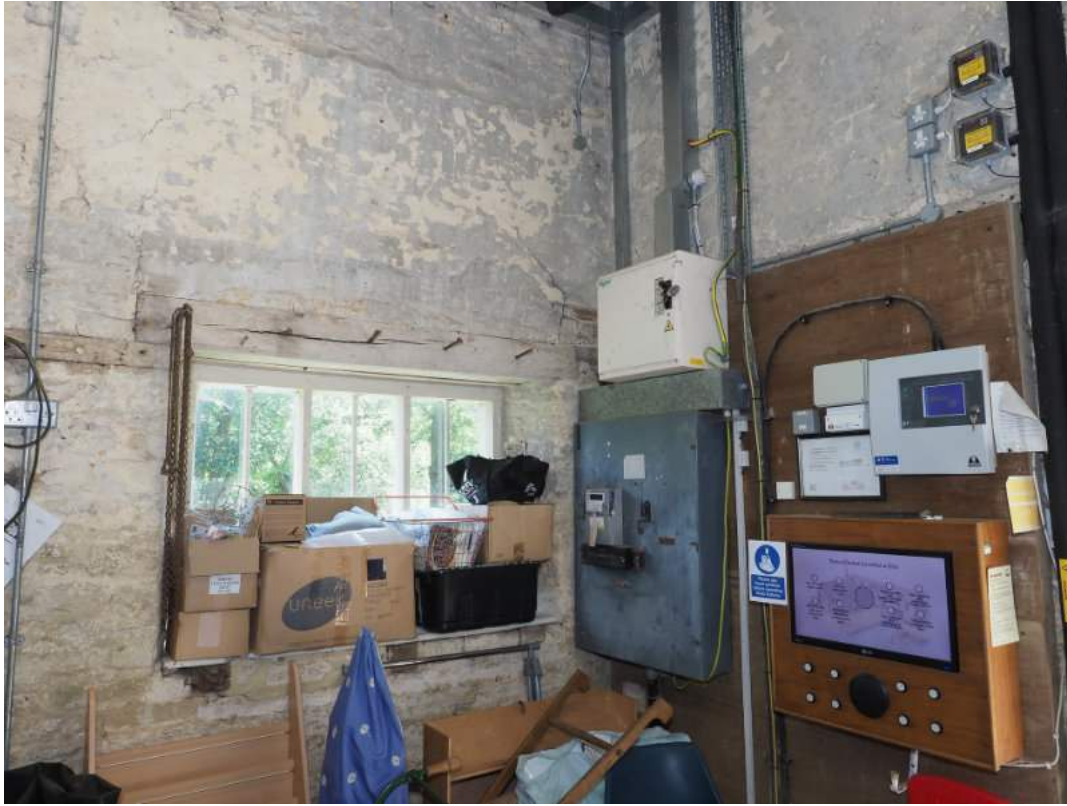
Image P6280208.jpg

**White switchbox upper left - main power incomer isolator**

**Cold water pipe heat tracing controllers - top right of photo**

**Fire and Smoke alarm system - middle right**

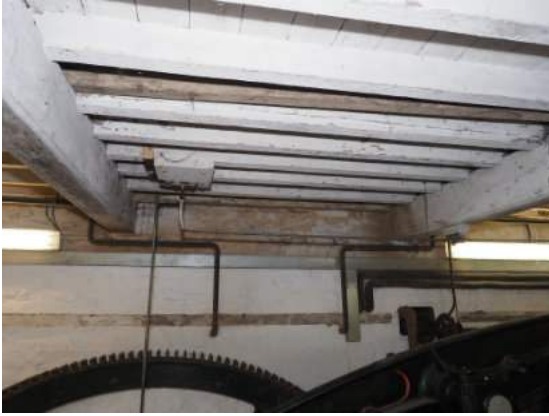
Image P6140131.jpg

Electrical trunking (galvanised) run at ceiling level

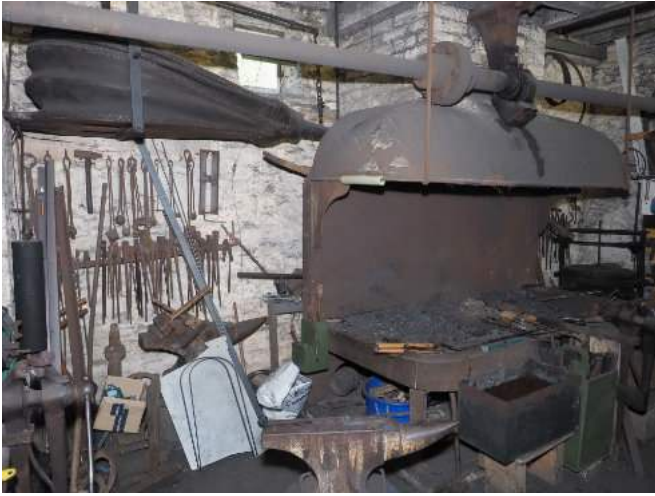
Image P6140140.jpg

**Flexible metal extract ducts removed together with electric extract fan housed in hood**

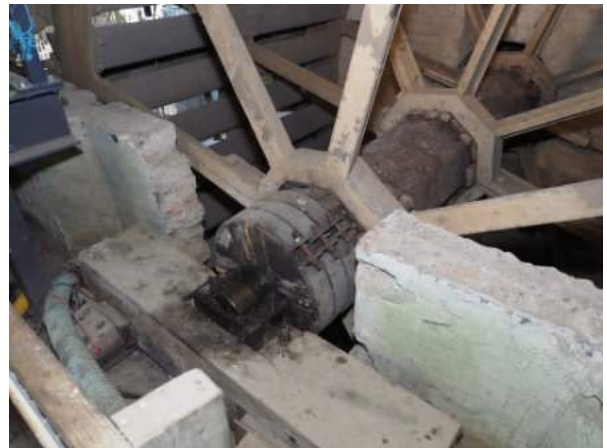
Image P6140160.jpg

**Waterwheel gudgeon bearings re-wedged and steel banded**

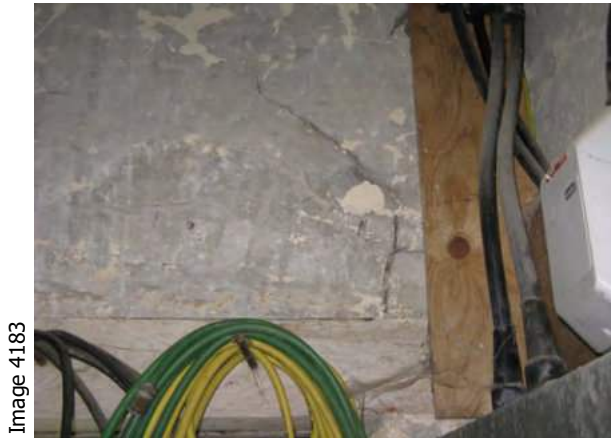
Image 4183

**Vertical crack in wall above window**

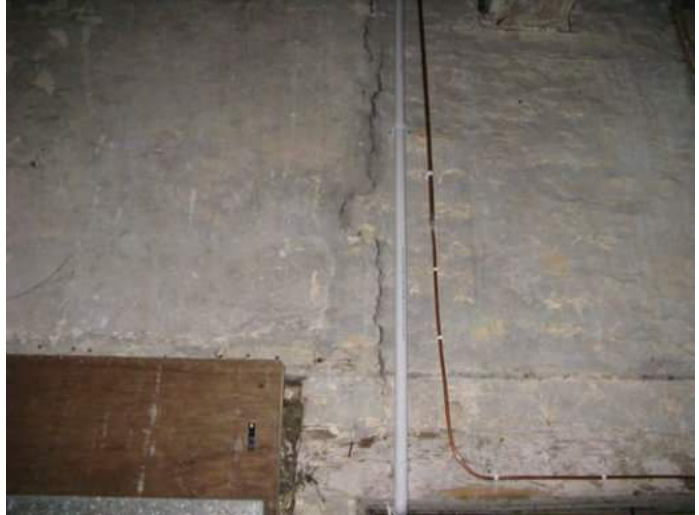
Image 4184

**Vertical crack in wall above end door rising through floor above**

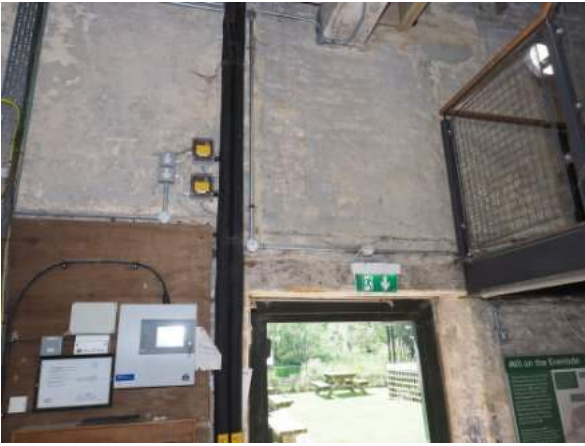
Image P6140159.jpg

**Stonework crack above door repaired**

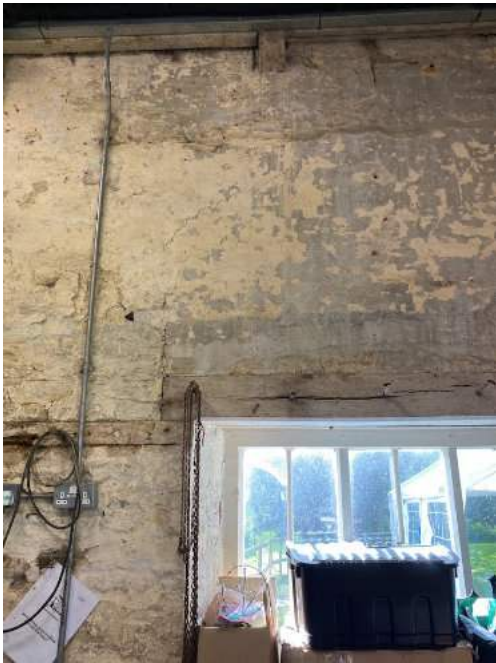
Image\_1330 .jpg

**Stonework crack above window repaired**

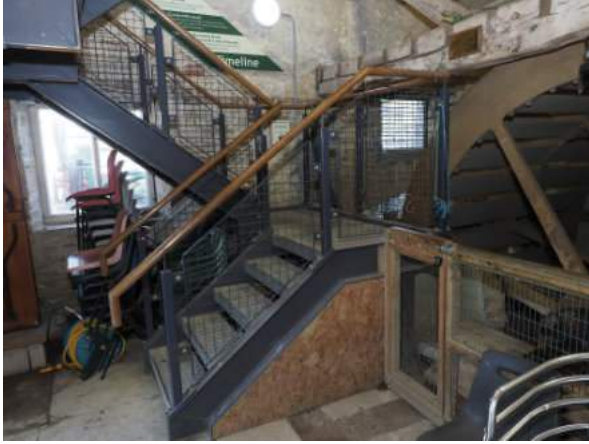
Image P6140067.jpg

**Old wooden staircase replaced with steel**

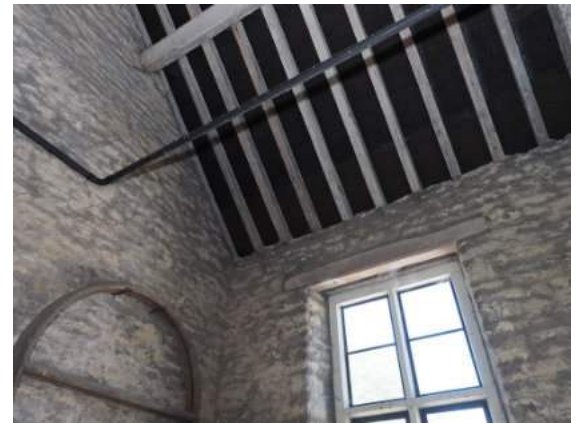
Image P6140074.jpg

**All wall plate timbers repaired and rafters partnered with new timber where needed**

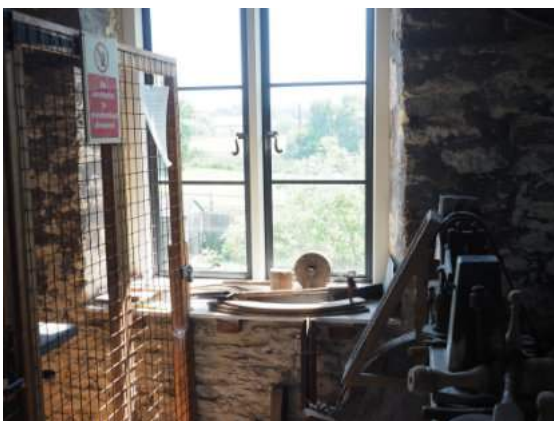
Image P6140088.jpg

**Stonework below window sills repaired throughout where necessary**

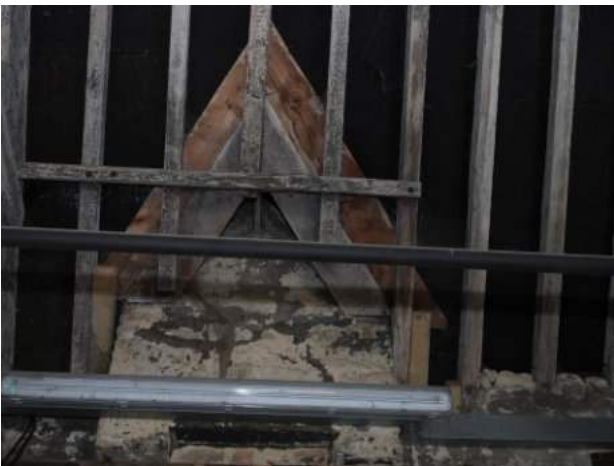
Image P6140082.jpg

Timber wall plates repaired or replaced

Rafters scarfed with new wood

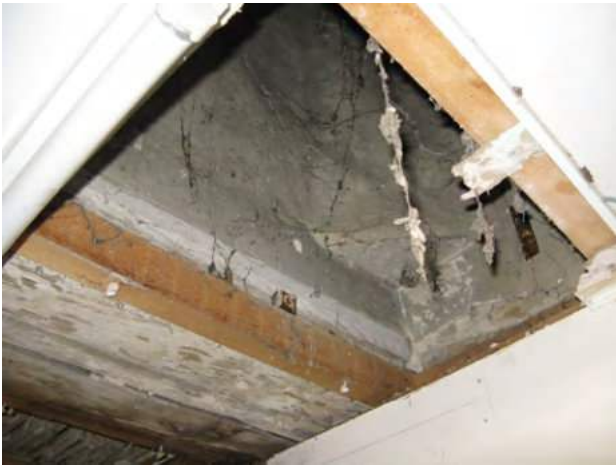
Image 2950

**View into bell tower through hatch with left hand ceiling plaster awaiting replacement**

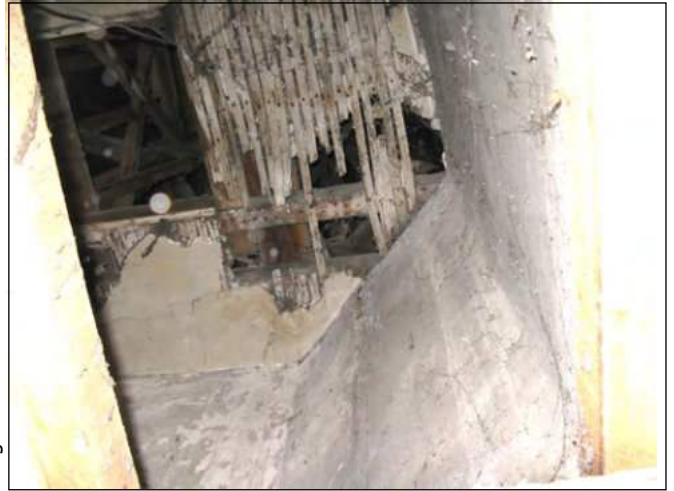
Image 2962

**Inner ceiling laths of bell tower viewed through turret hatch**

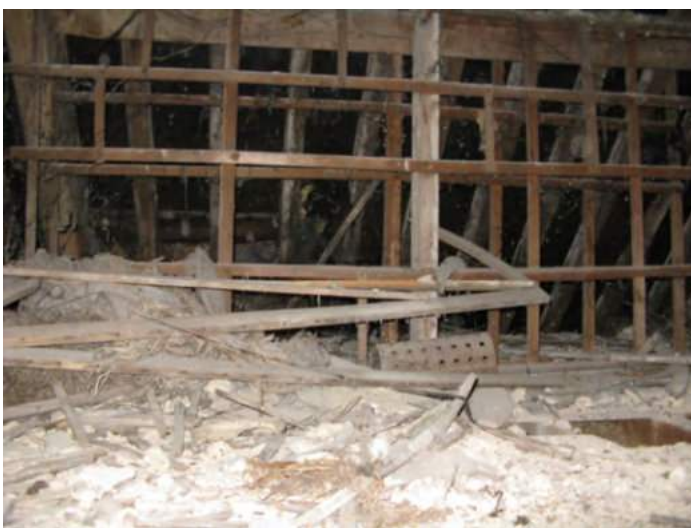
Image 3015

**Views of the Education Room roof space. There is a false modern ceiling overlaying the original lath and plaster one. Light was seen coming through a pin-hole in the roof - there was no sign of water damage.**
