# **COMBE MILL**

## **Building Condition Report**

**August 2023**

Prepared for Combe Mill Society by Tony Simmons

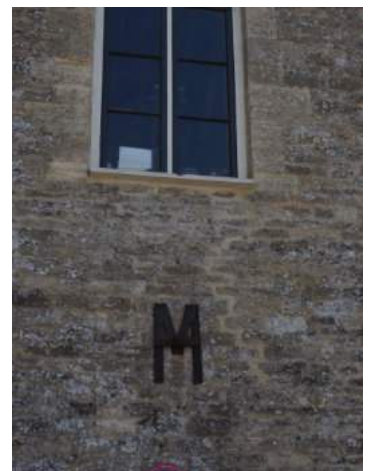
**Showing repaired crack in stonework**

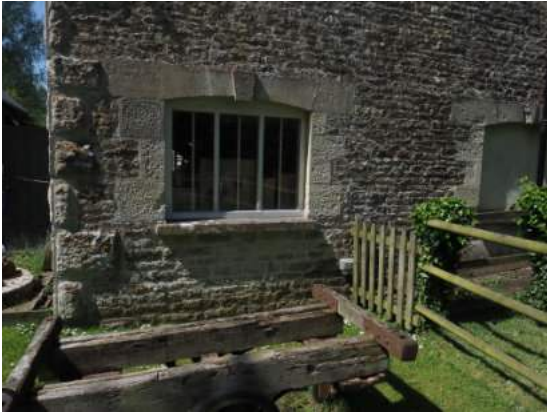
Image P5240037.jpg

**Repaired window of waterwheel room**

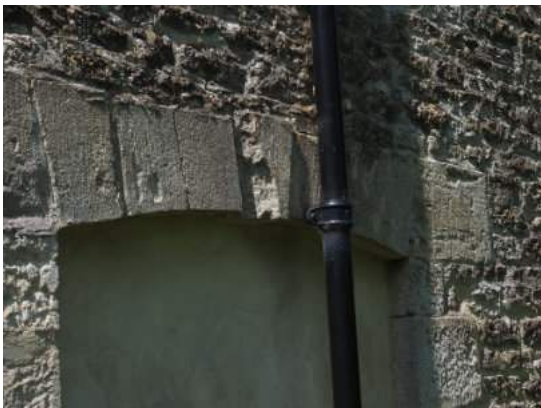
Image P5240045.jpg

**Repaired window of waterwheel showing stonework damage on keystone**

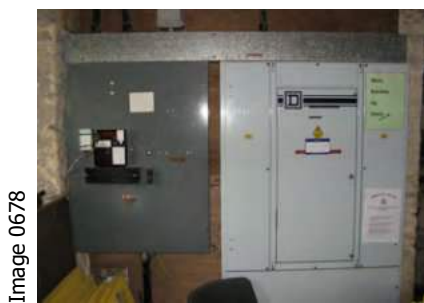
Board A - incoming 3 phase

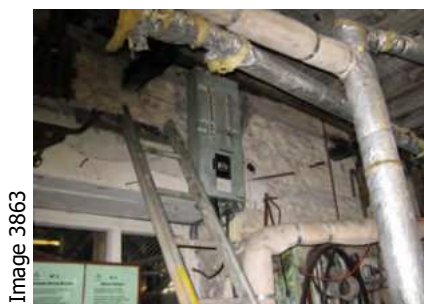
Board B - 3 phase distribution

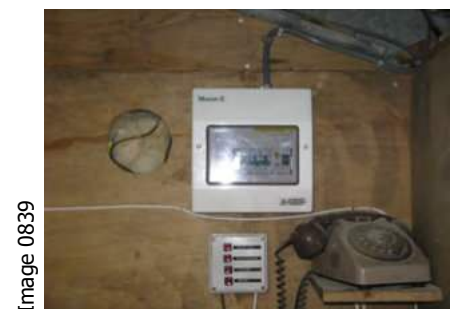
Board C - boiler house and disabled toilet

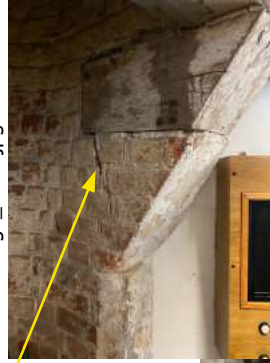
Image\_1342.jpg

Crack in brickwork supporting beam

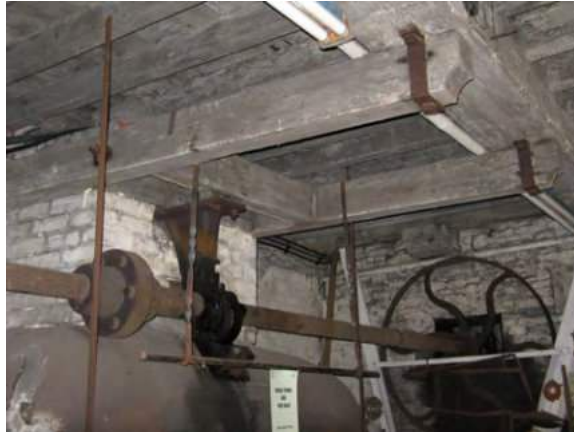
Views showing ceiling beams in forge/workshop

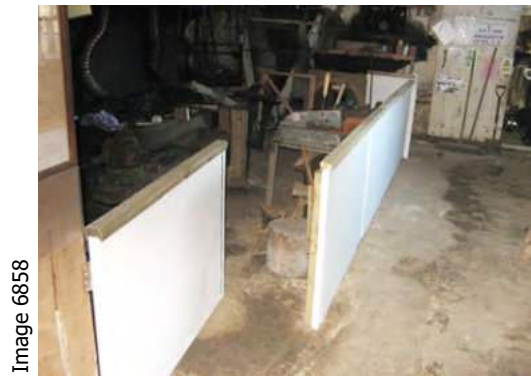
Spark resistant safety barriers across forge area erected February 2008

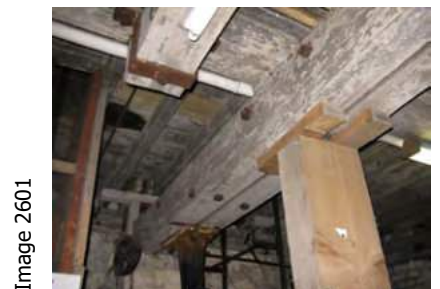
Prop beam in workshop

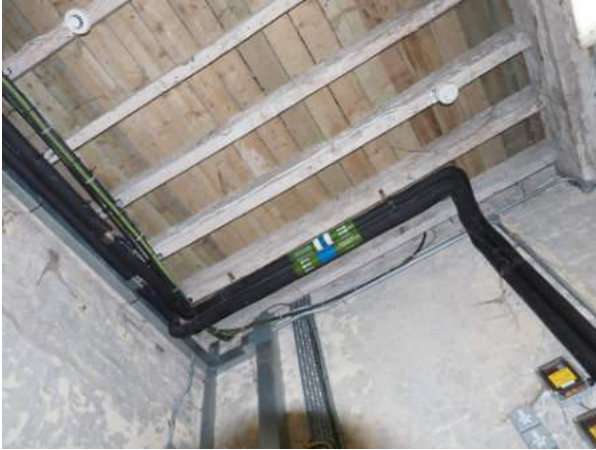
Image P6280205.jpg

**New cold water pipes lagged and heat traced**

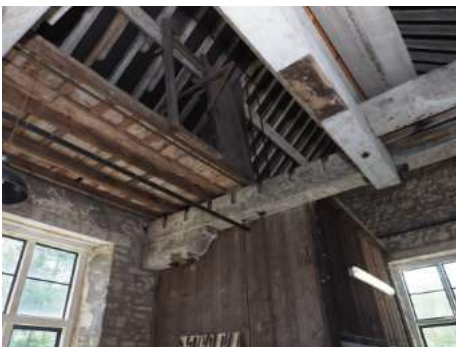
Image P6140079.jpg

**Old roof slates replaced with tiles in this quarter of roof**

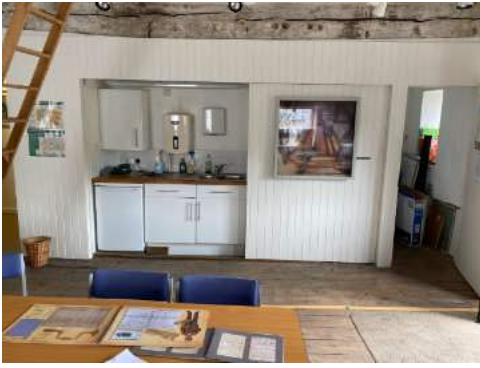
**New kitchenette/ bookshelves installed under steel beam**

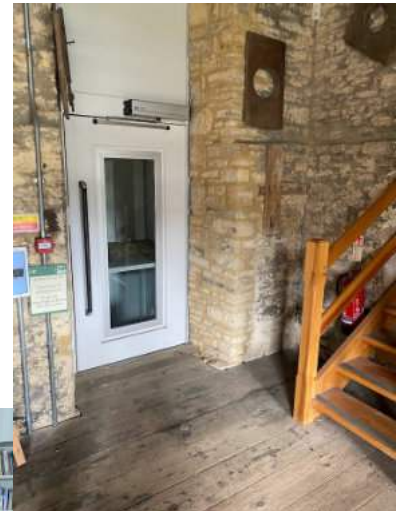
**Lift landing on second floor - was a window opening**
