# **COMBE MILL**

## **Building Condition Report**

**August 2023**

Prepared for Combe Mill Society by Tony Simmons

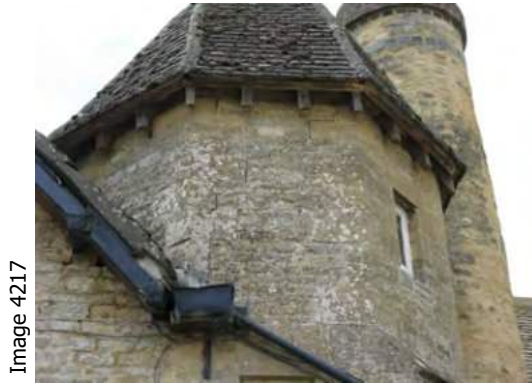
Image 4217

Crack in wall of turret

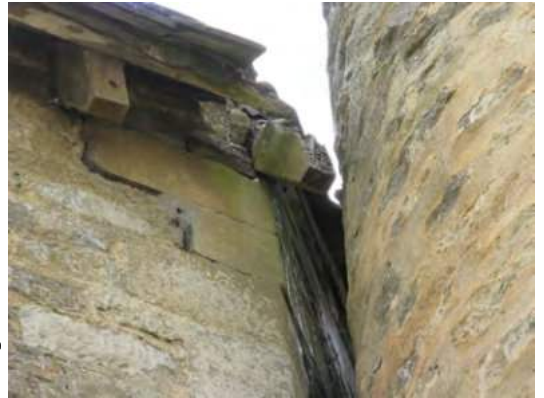
Image 4222

Damage to turret roof against chimney

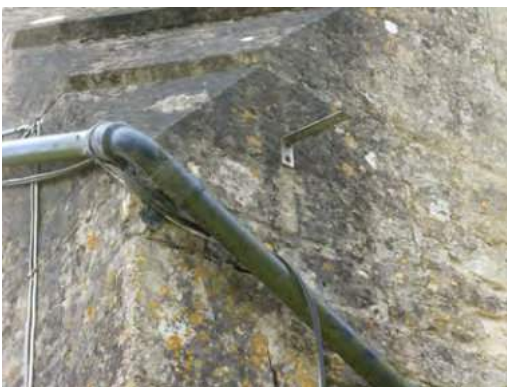
Image 4221A

Condition of corner of front wall

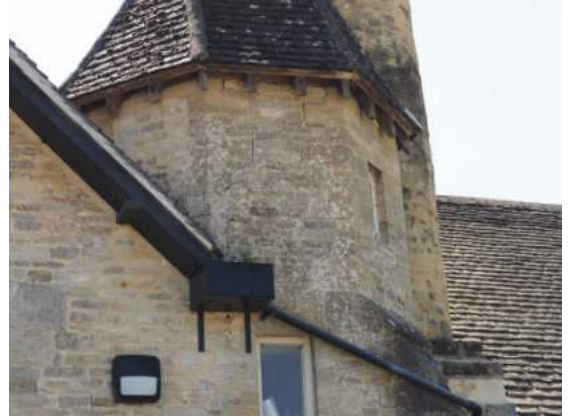
Image P524007.jpg

**Repaired turret roof against chimney**

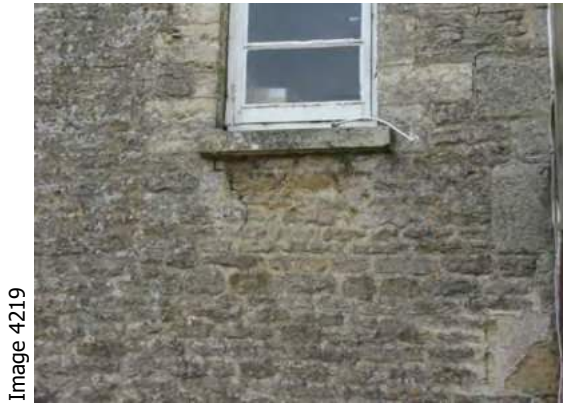
Image 4219

**Cracks in rubble wall below front window of Education Room**

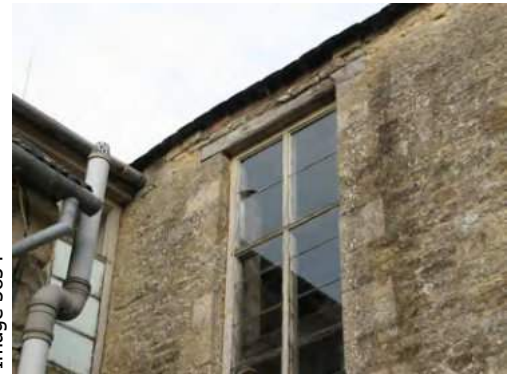
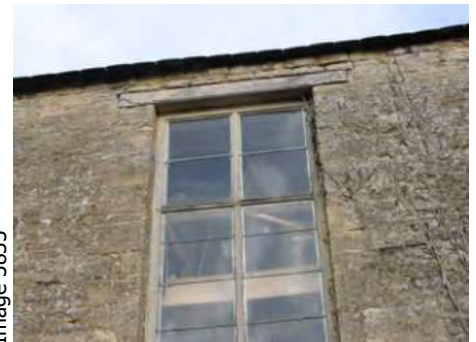
**Typical state of windows - timber  
unpainted - large gaps around edges -  
poor glazing**

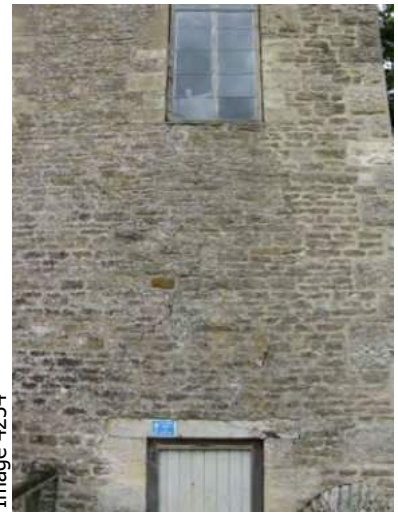
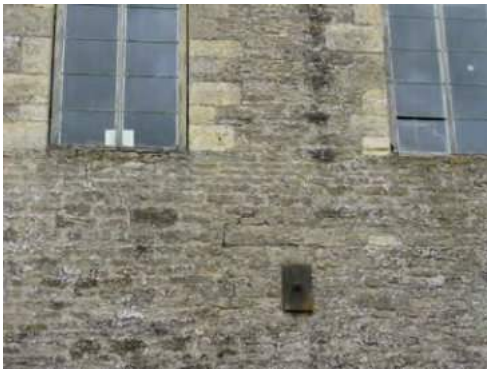
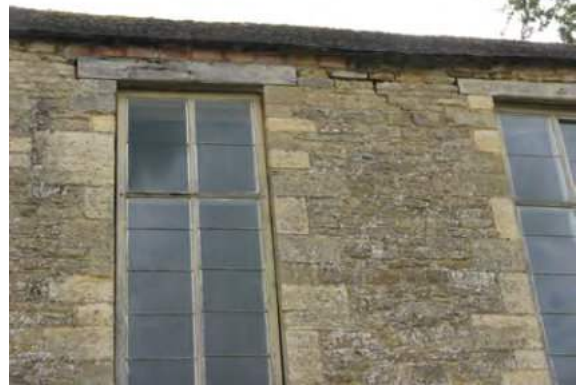
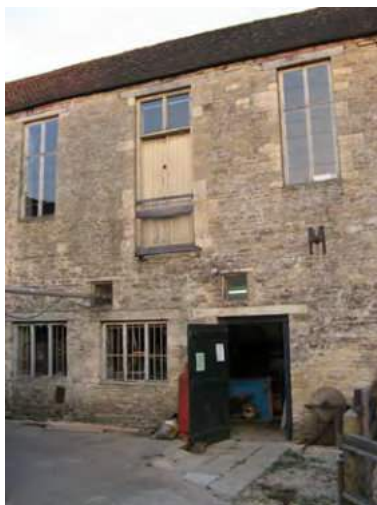
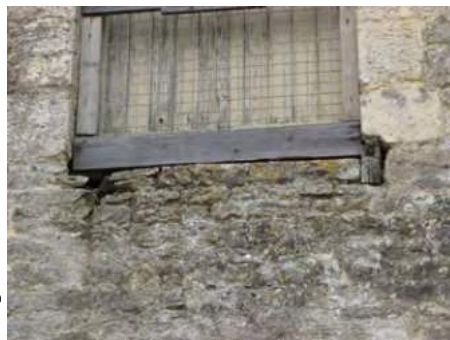
### Typical state of rubble walls showing strengthening plates and cracks

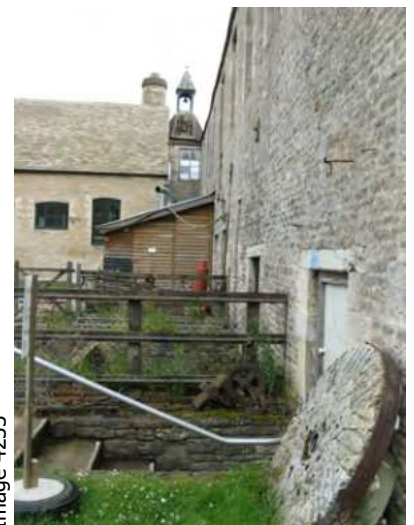
Image 4233

### View of yard wall - loading bay door surrounds show loss of stonework and rotting timbers

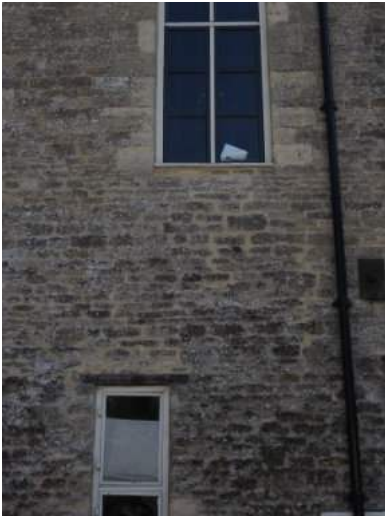
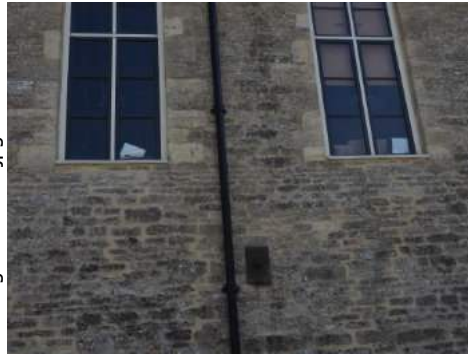
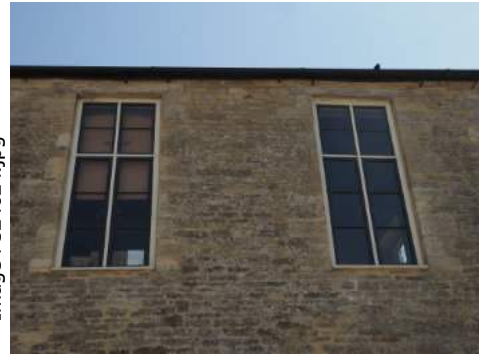
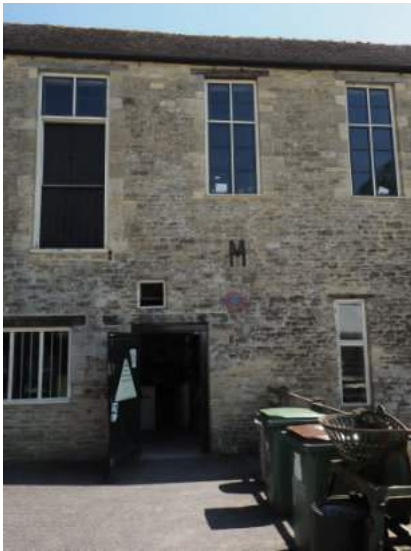
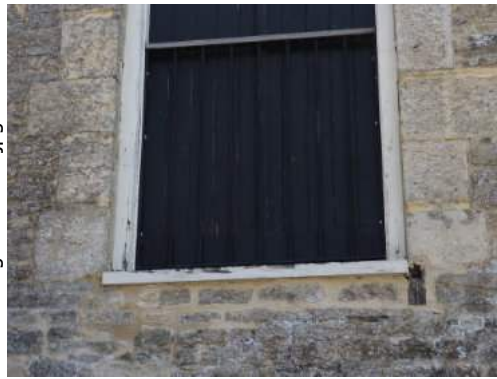
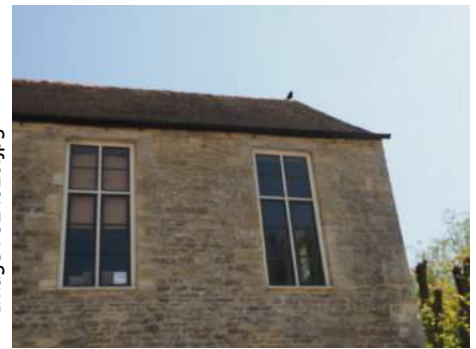
**View of yard wall - loading bay door repaired timber and stonework**

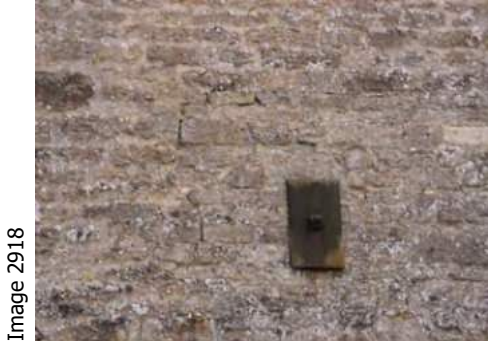
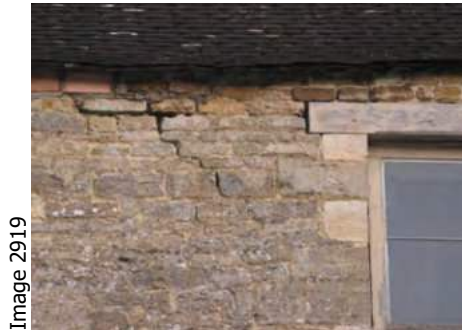
**Typical state of rubble walls showing another strengthening plate and cracks**

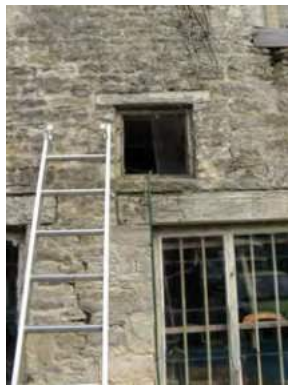
Image 3729

**Small vent above rear forge door and associated cracks and distressed timber lintel**

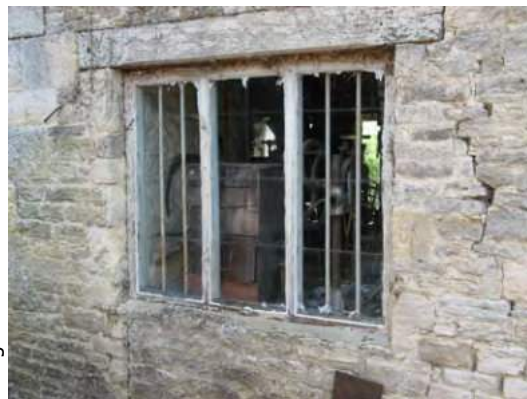
Image 0557

**Workshop window to left of rear forge door with associated cracks and distressed timber lintel**

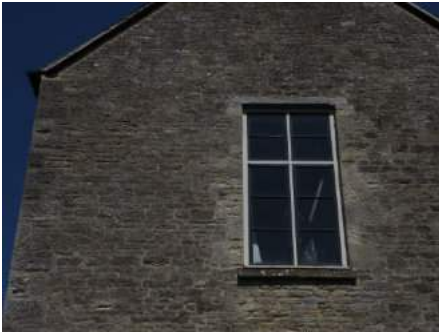
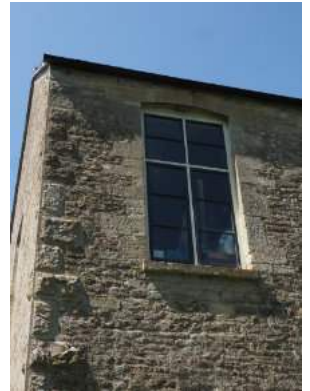
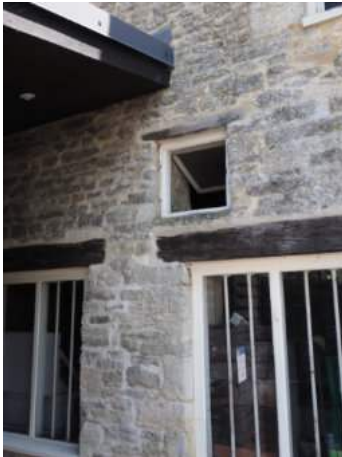
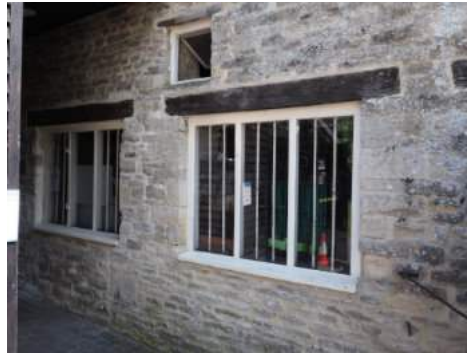
**Repaired ground floor windows**

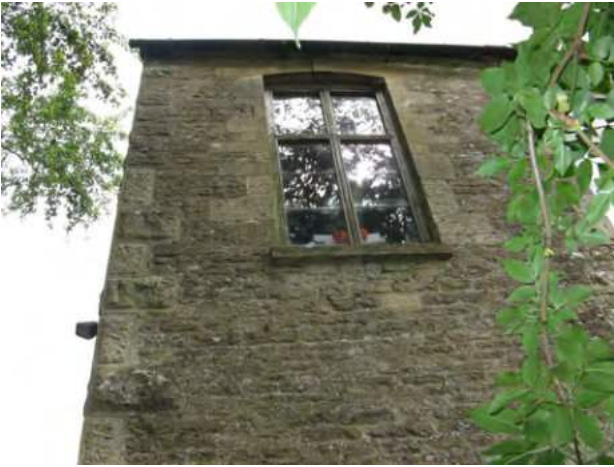
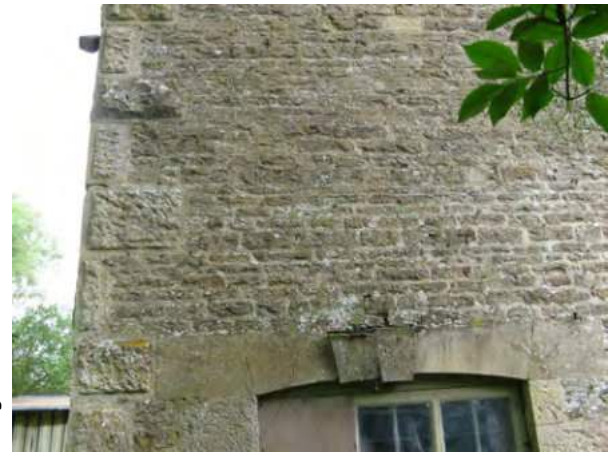
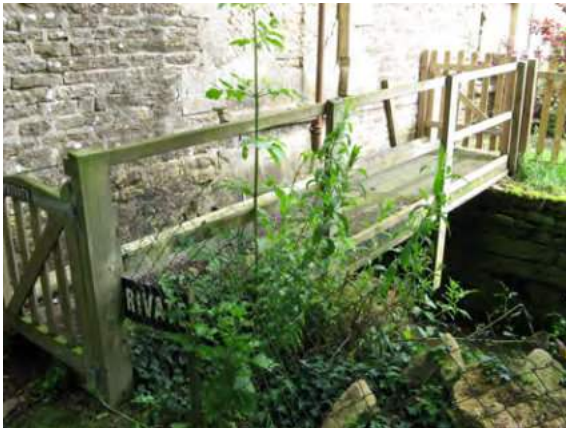
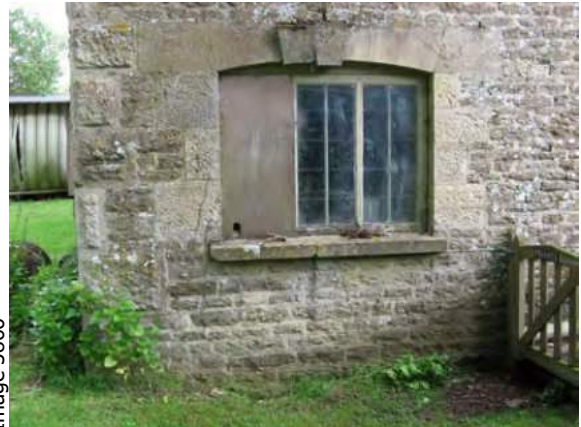
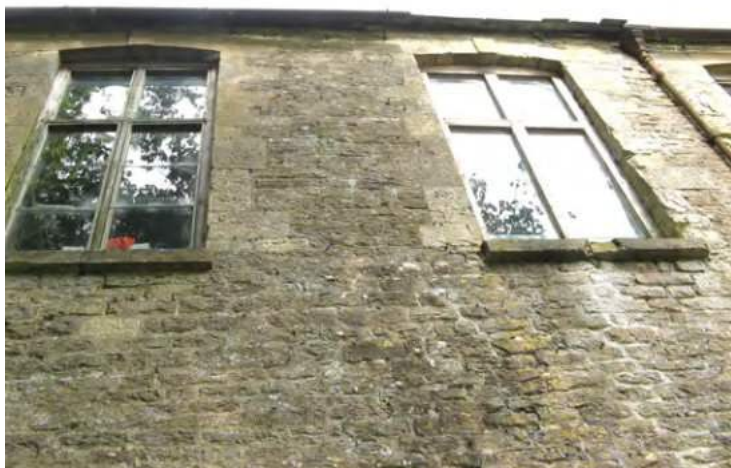
Series of images showing lack of guttering, broken stone window lintels and cracks in rubble wall

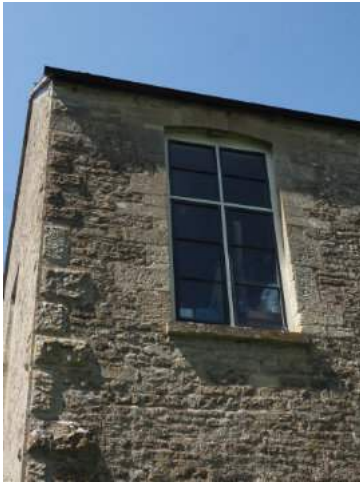
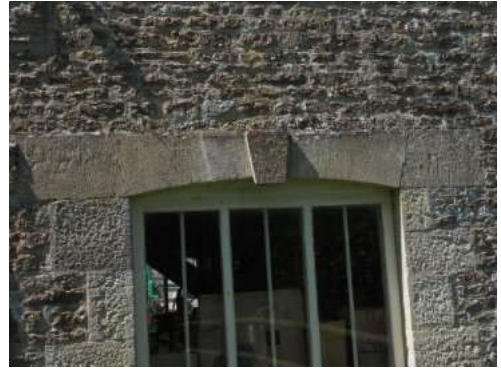
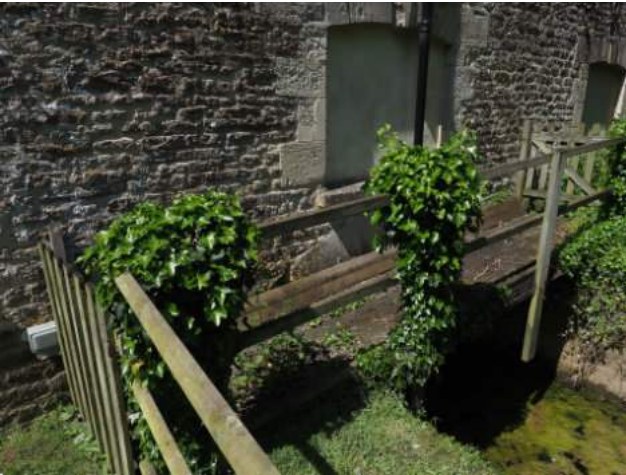
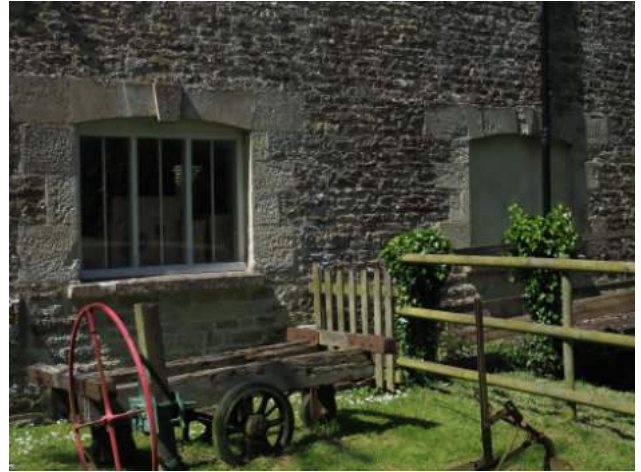
**Series of images showing added guttering, repaired stone window lintels and repairs to rubble wall  
Chimney height raised to above roof crest to stop smoke in forge**

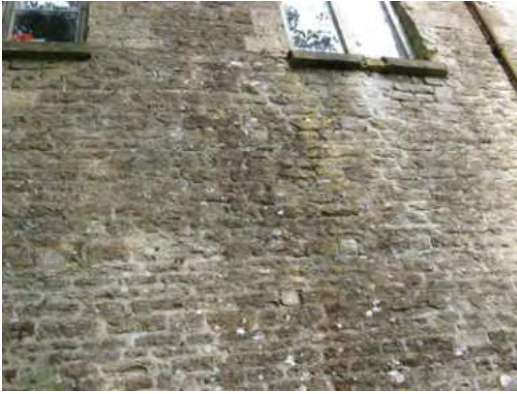
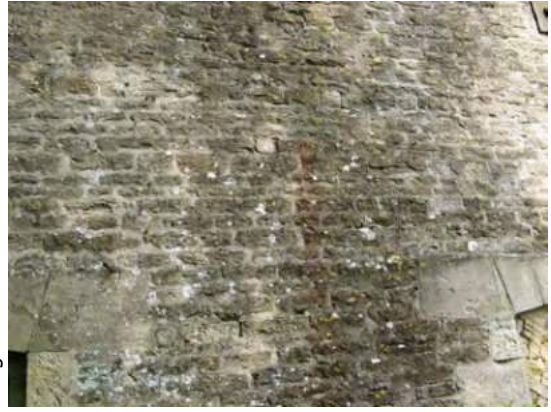
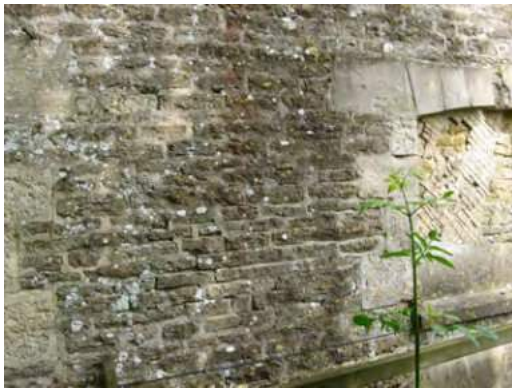
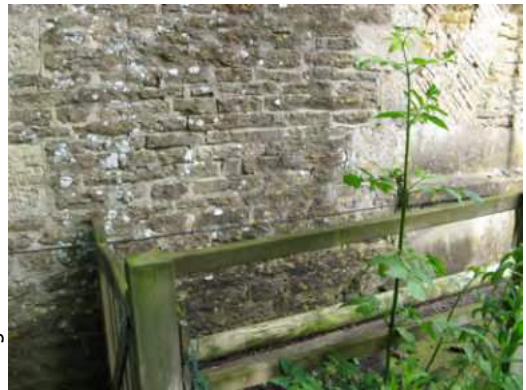
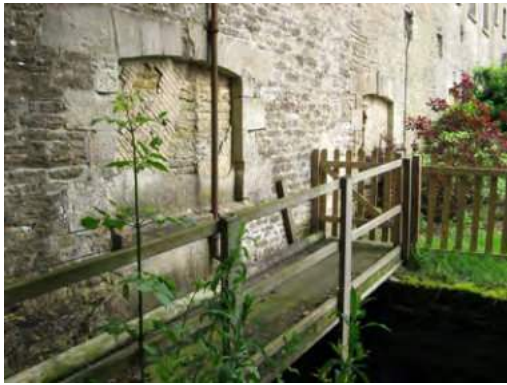
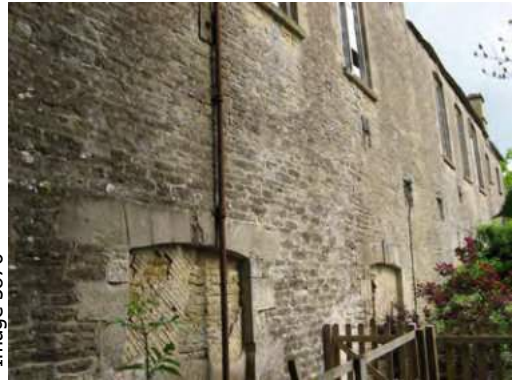
**Further images showing lack of guttering, broken stone window lintels and cracks in rubble wall**

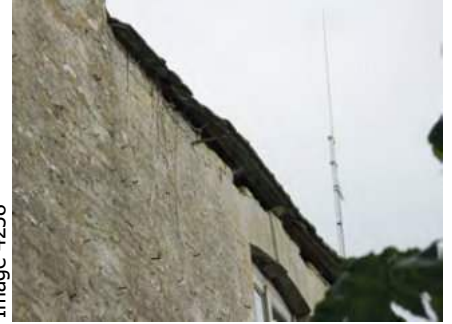
Image 4238

**Undulating line of roof**

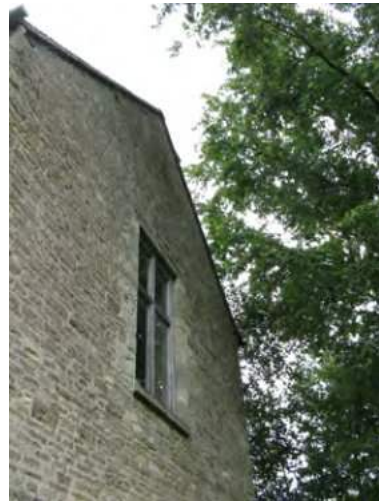
Image 4235

**NOTE**  
proximity of tree branches to end wall of mill

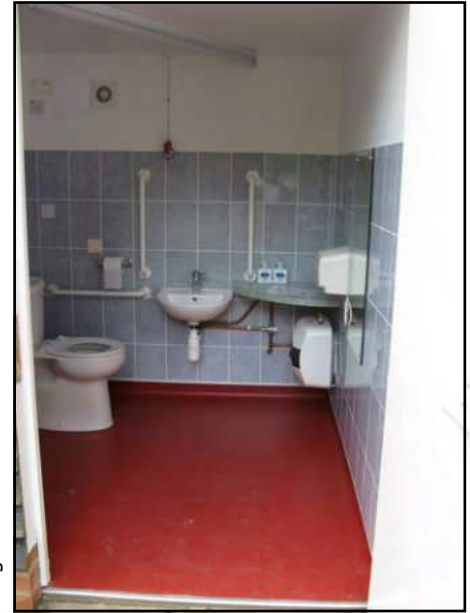
Image 1920

**Lean-to boiler house with disabled toilet nearest to camera**

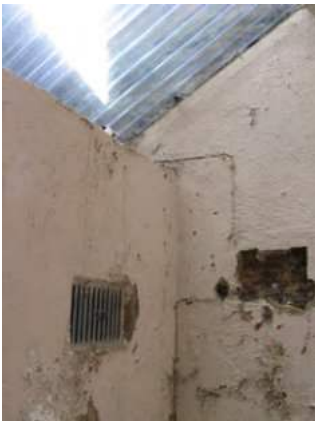
Image 4241

**State of the inside of the 'old' toilet - clear plastic roof was partially replaced after being damaged during site redevelopment but is not water tight.**

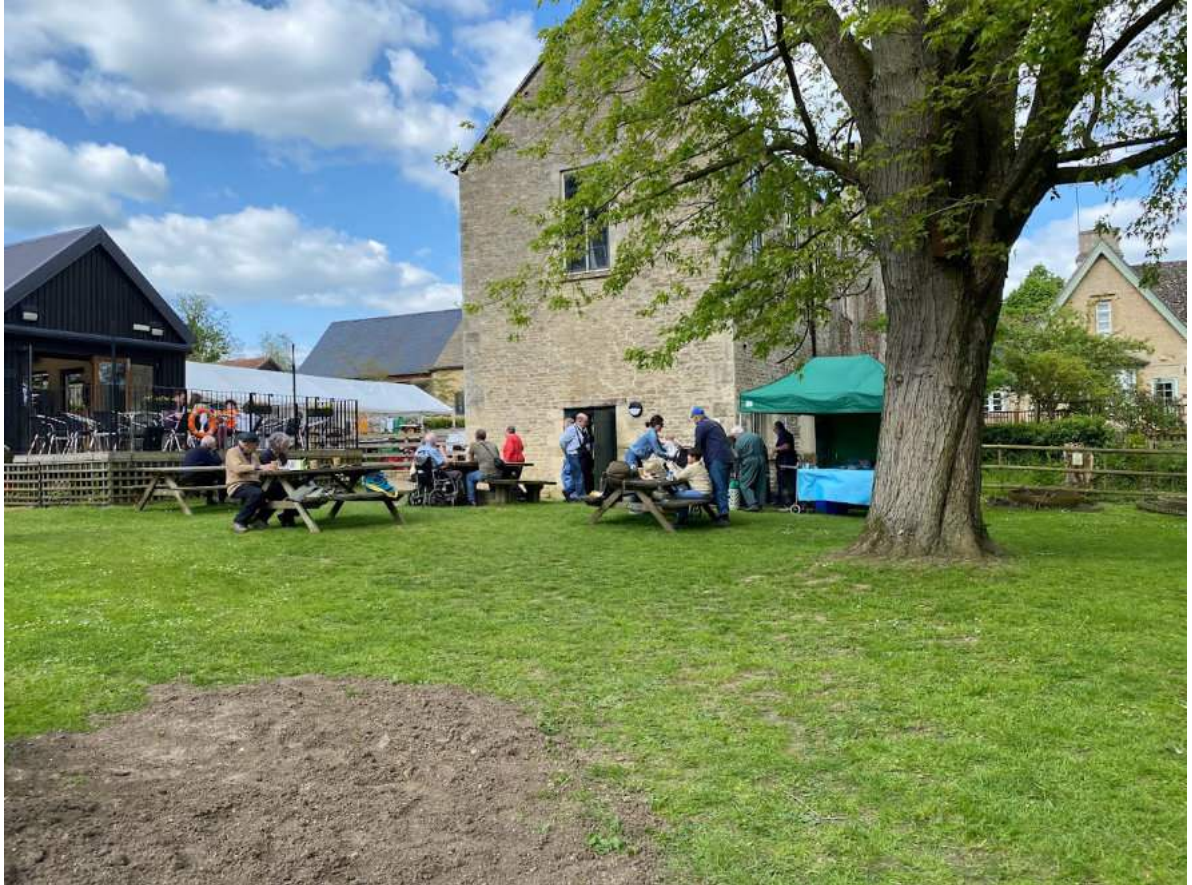
Image\_1147 .jpg

**Tea Room is supported on piling to be above average flood levels  
It comprises two WC, electrical cupboard, servery and seating area.**

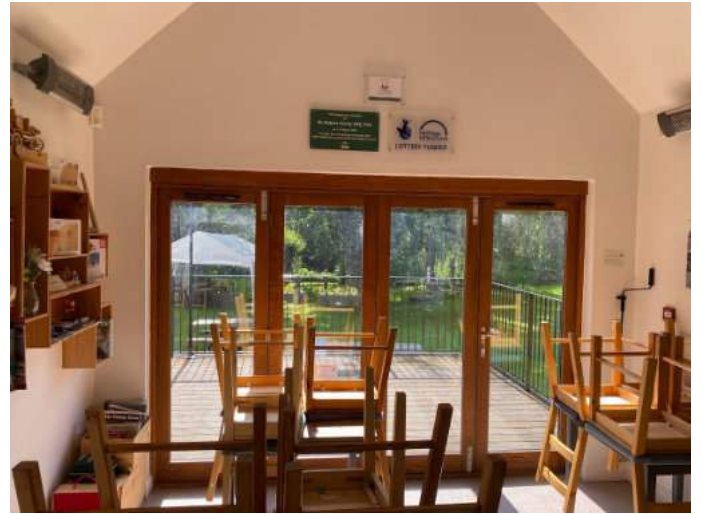
Image \_1373.jpg

Folding glazed doors to decking area.

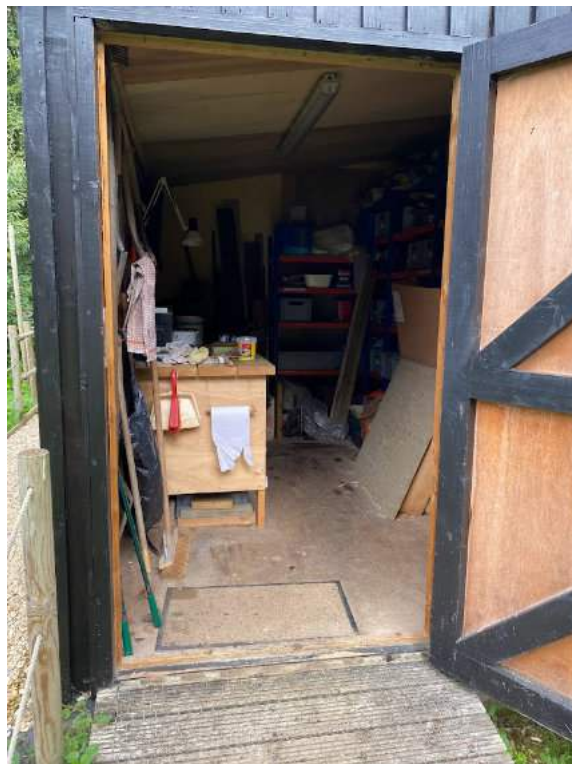
**Timber shed clad to match tea room. Tar paper lined, insulated and ply clad**  
**Supplied with power and lighting from spur off tea room distribution board**

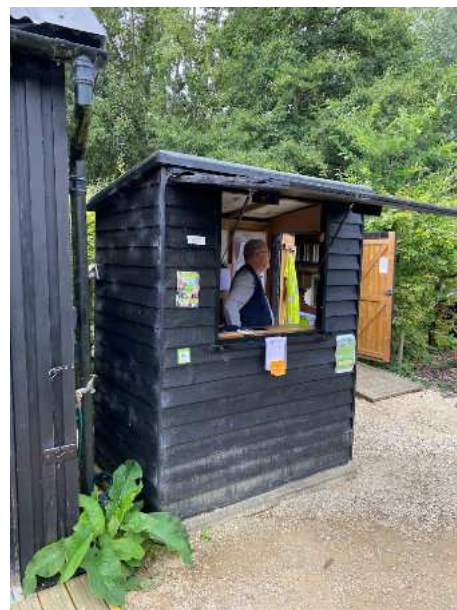
**Timber shed with lift up serving hatch and end door for access.**

**Supported by a concrete slab which can be seen to rise and fall due to ground freezing from buried heat source piping that serves the Old Sawmill building.**

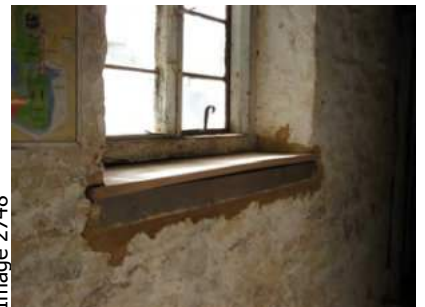
Image 2748

**State of Engine Room window showing ill fitting metal frame and repaired window sill**

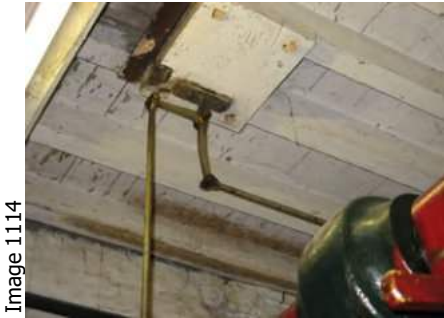
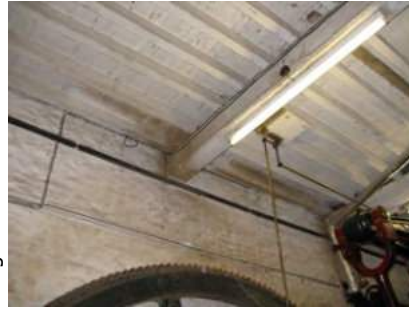
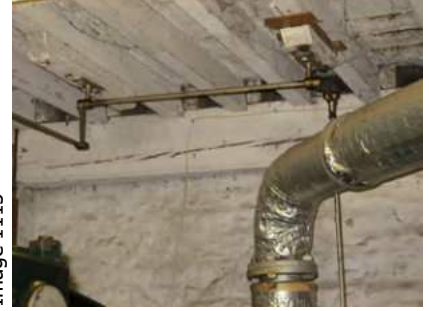
Views showing condition of engine room ceiling

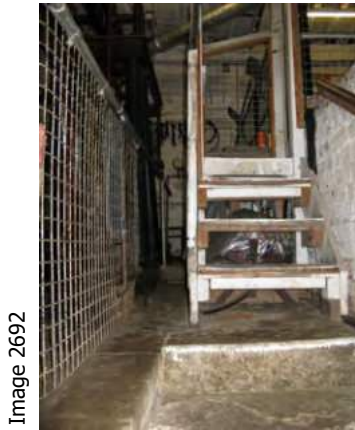
Image 2692

View of wooden steps descending from top of Cornish boiler

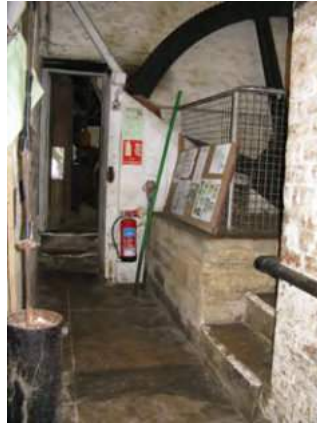
Image 2693

View at base of steps towards forge

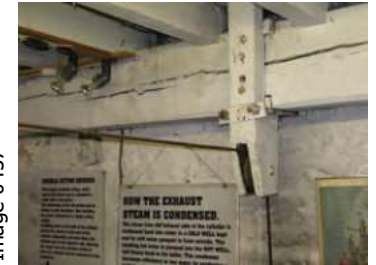
Image 0457

Chimney damper operating cable

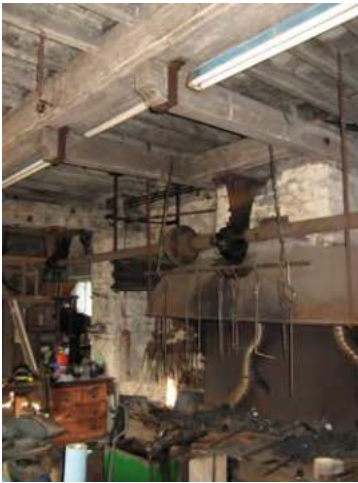
Views showing ceiling beams in forge/workshop

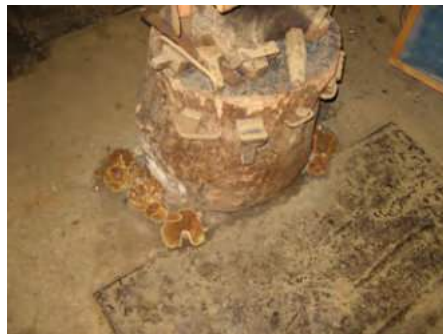
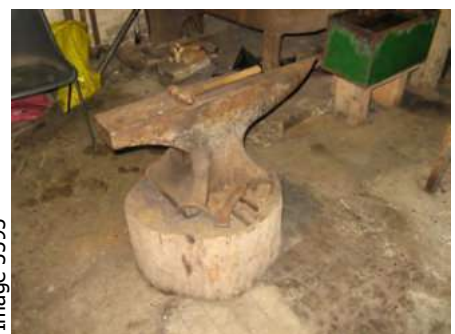
Condition of workshop floor in area of forge

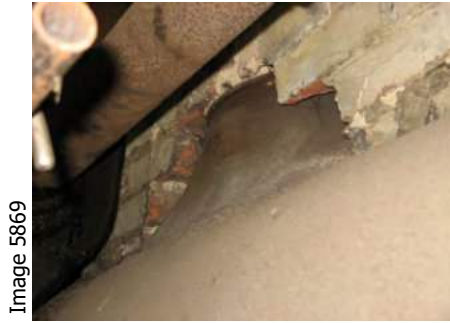
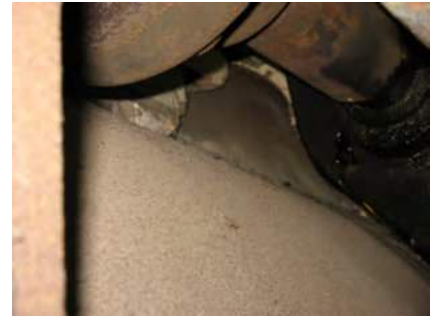
Views showing forge hood/flue entering chimney

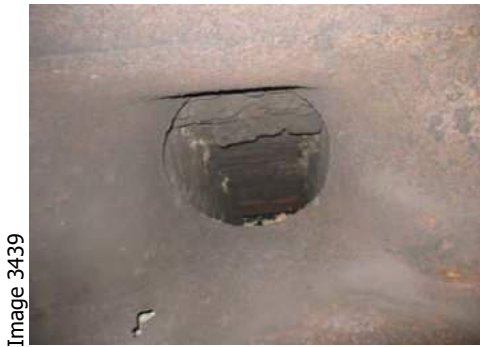
View up forge chimney

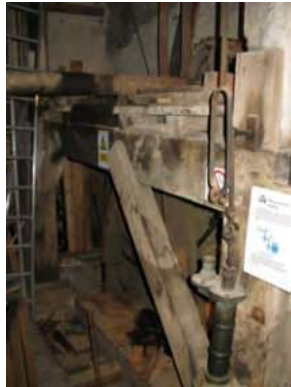
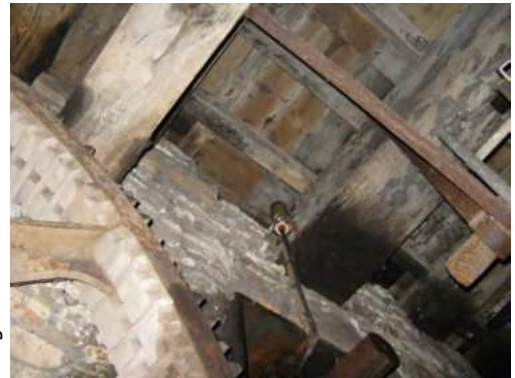
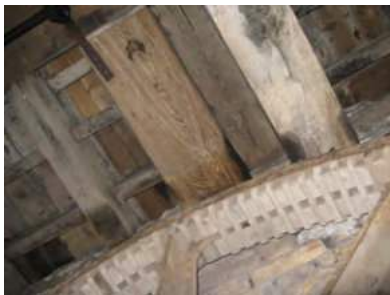
Photographs showing complex beam arrangements within water wheel gear room

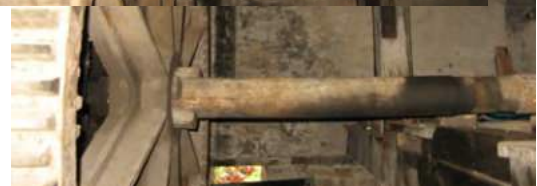
Image 4023

Unrestored second gear and lay-shaft

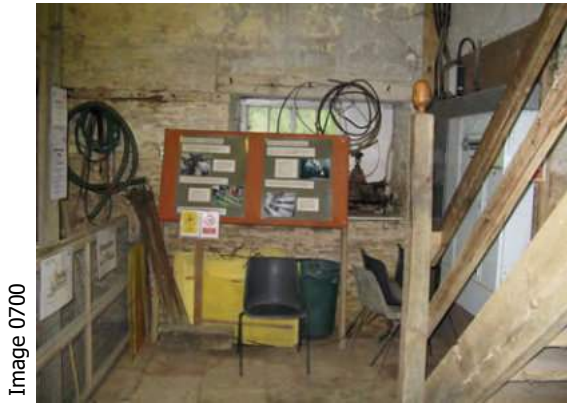
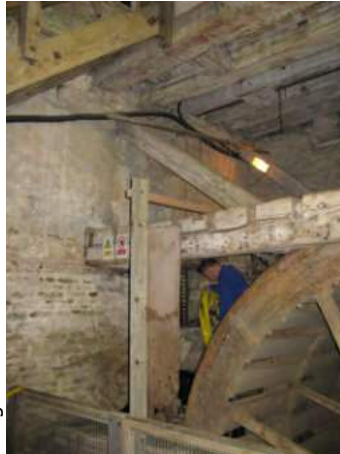
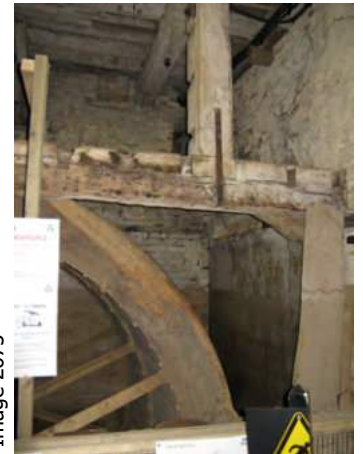
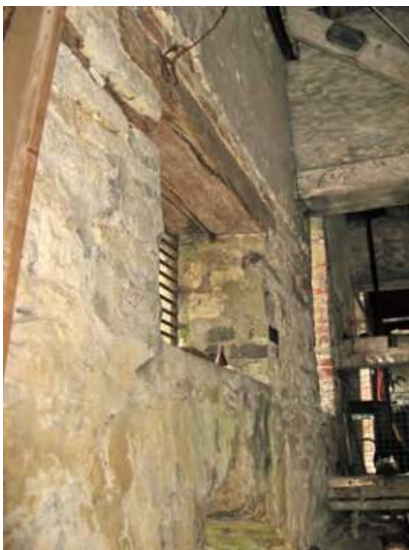
Photographs showing various views of the waterwheel room

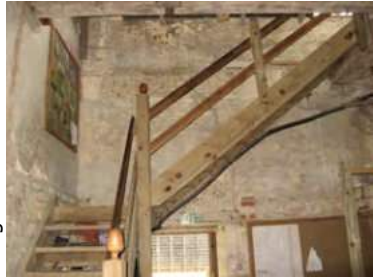
Image 3998

**View of staircase from ground floor**

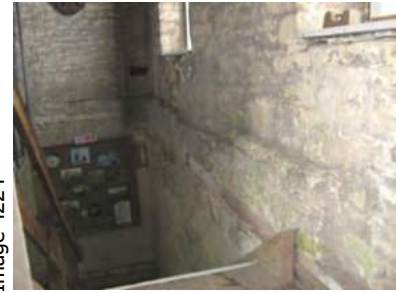
Image 4224

**View back down staircase - before handrails were fitted**

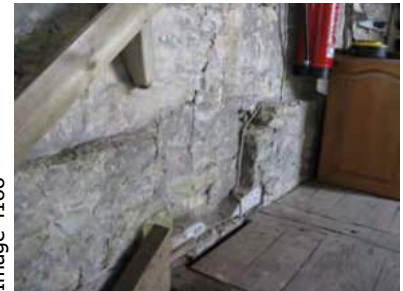
Image 4188

**Wall and window sill at top of stair way**

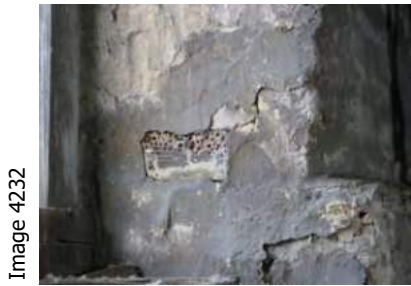
Image 4232

**Old timber embedded in stonework**

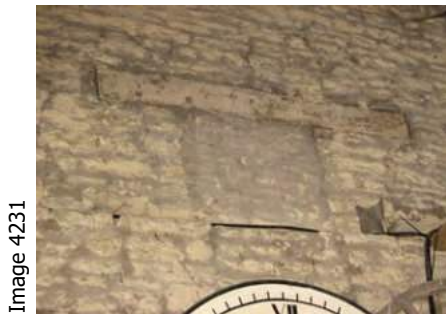
Image 4231

**Blocked aperture in wall of Pattern Shop**

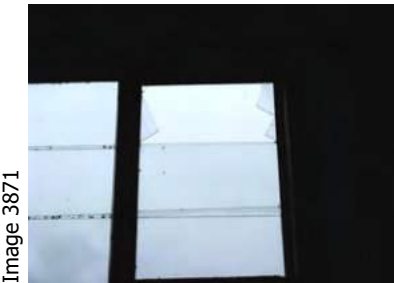
Image 3871

**Broken glass pane - typical**

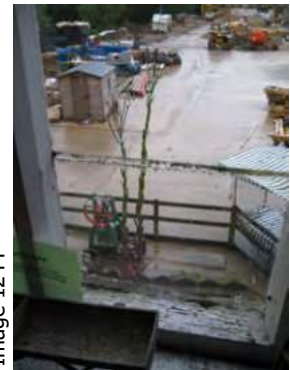
Image 1244

**Weed growing on outside of rotten window sill**

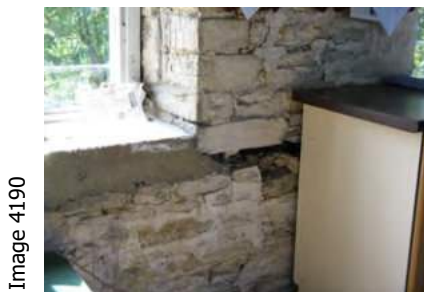
Image 4190

**Window sill replaced with cement in the past and state of stonework surround - in refreshment area**

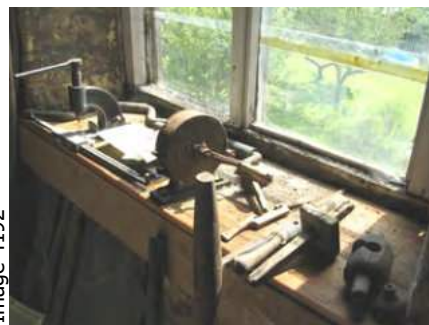
Image 4192

**Partly repaired window sill with rotten window frame visible**

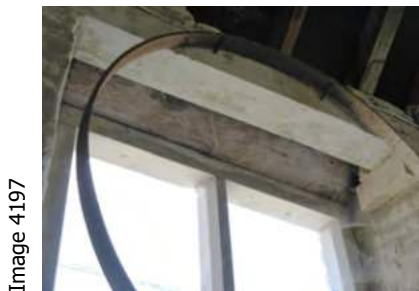
Image 4197

**Another window lintel with signs of wood rot**

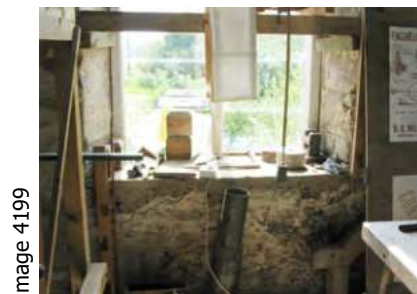
Image 4199

**Window sill behind historic clock display repaired with cement**

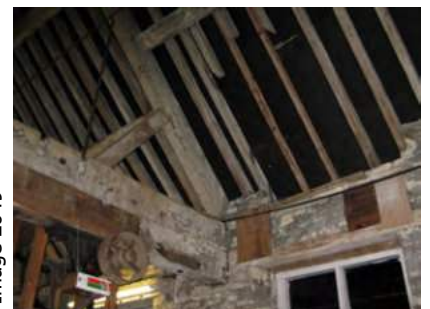
Image 2649

**Above window showing roof construction where once a dormer light existed - this is the case for each alternate window bay**

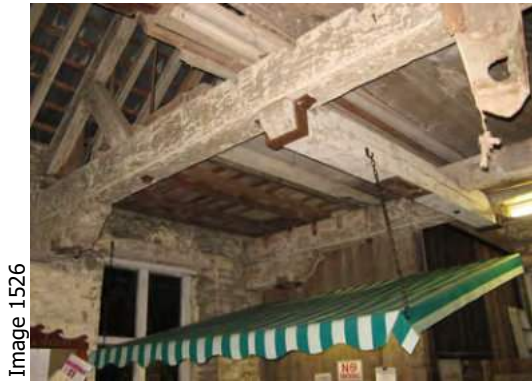
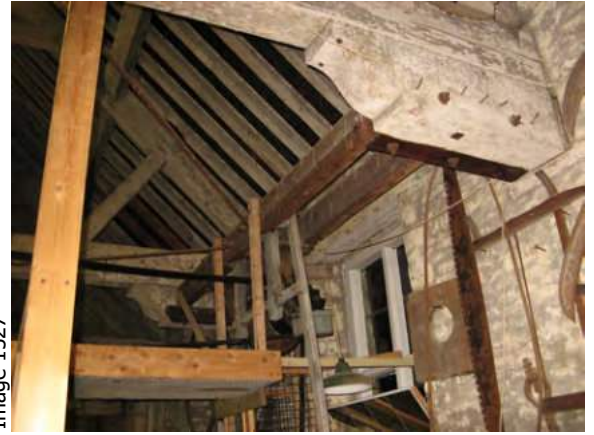
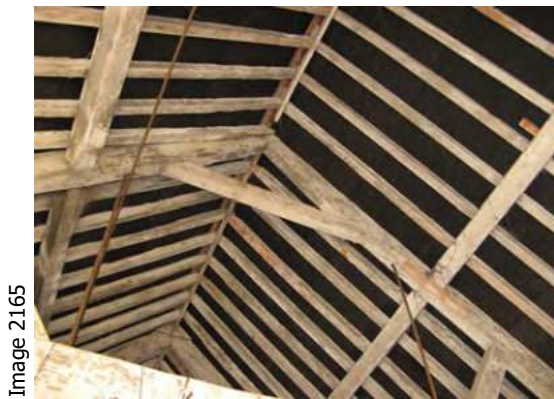
Various views of roof beams

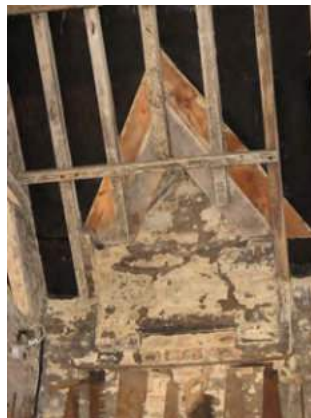
Image 2167

Roof beam arrangement around forge chimney

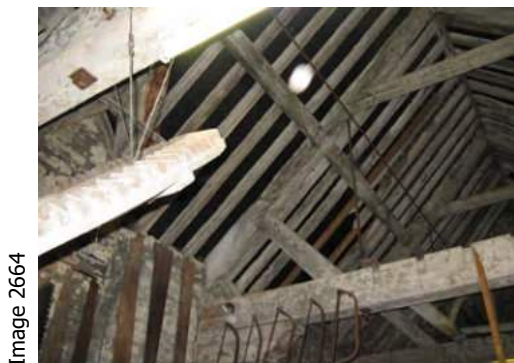
Image 2664

Sunshine through one of the holes in the roof

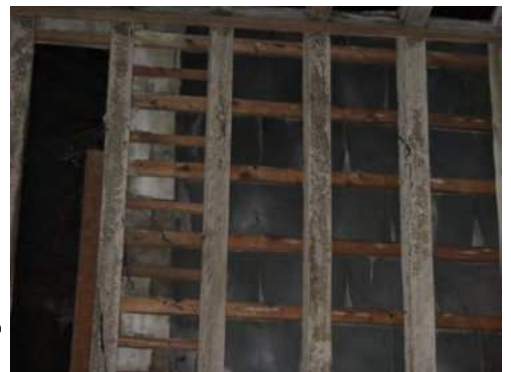
Image 2667

Showing transition between two styles of roofing

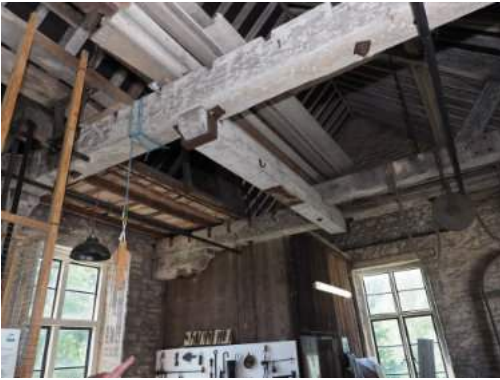
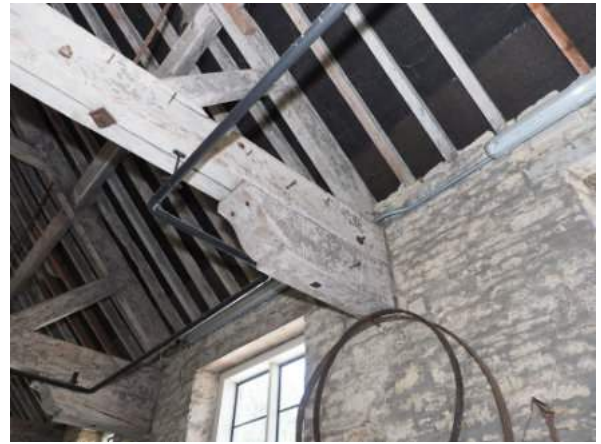
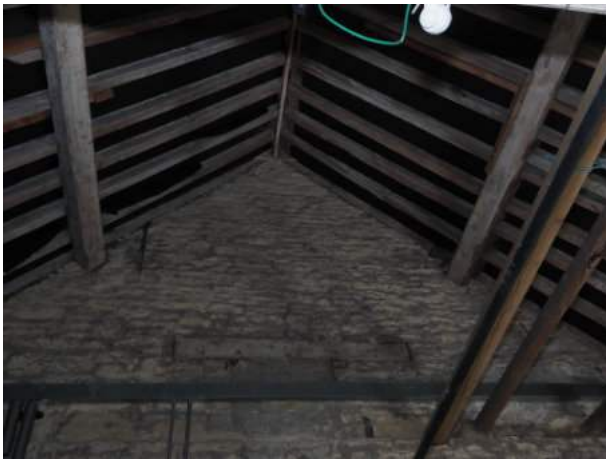
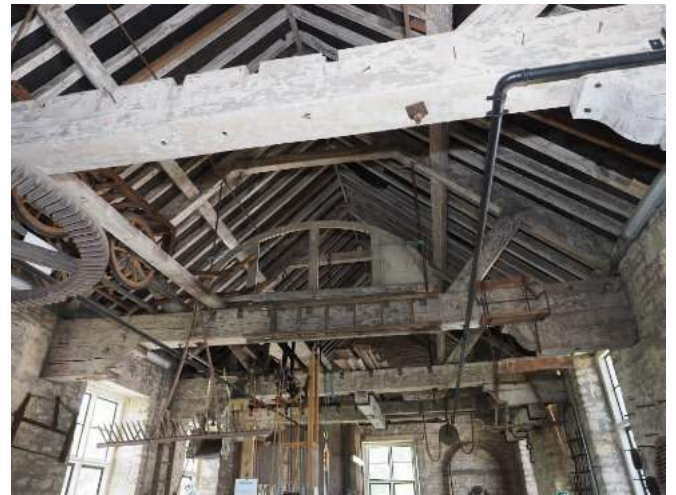
Timber wall plates repaired or replaced

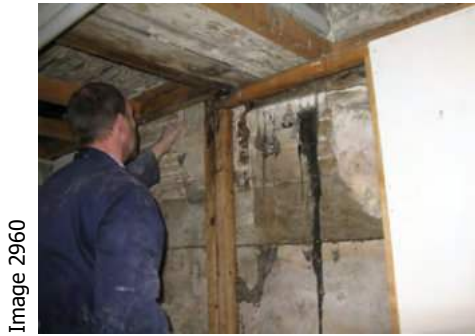
Image 2960

State of wood rot adjacent old sawmill before re-plastering in June 2009

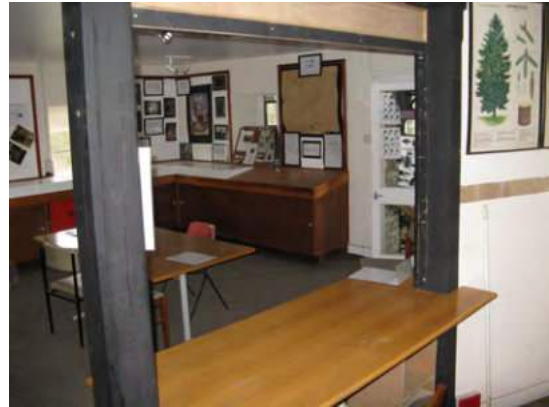
Image 2439

View into education room from 'corridor' - the two vertical black columns support the structurally weakened main beam that carries the turret

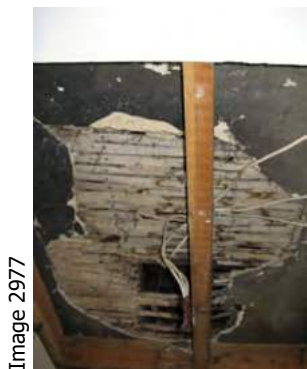
Image 2977

State of toilet ceiling before re-plastering in June 2009

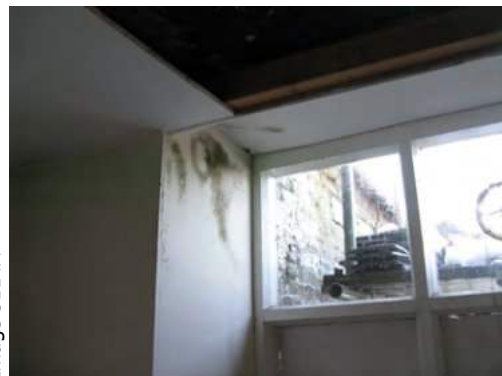
Image 3114A

Typical damp patches around toilet window plus deteriorated paint to obscure the window

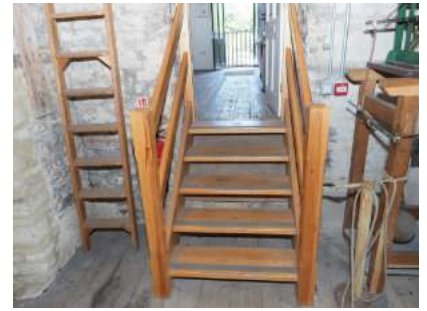
**Stairs to Foreman's Office replaced**

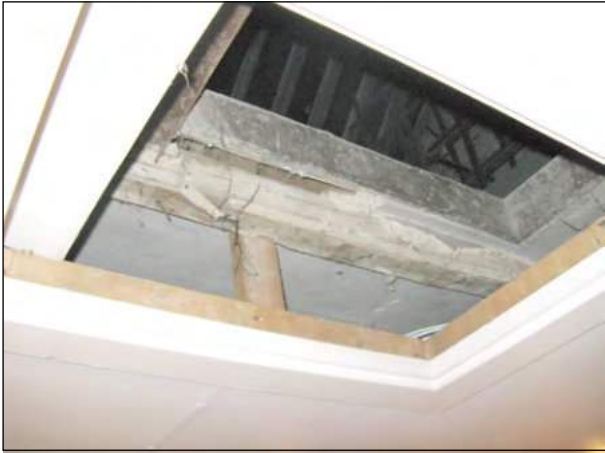
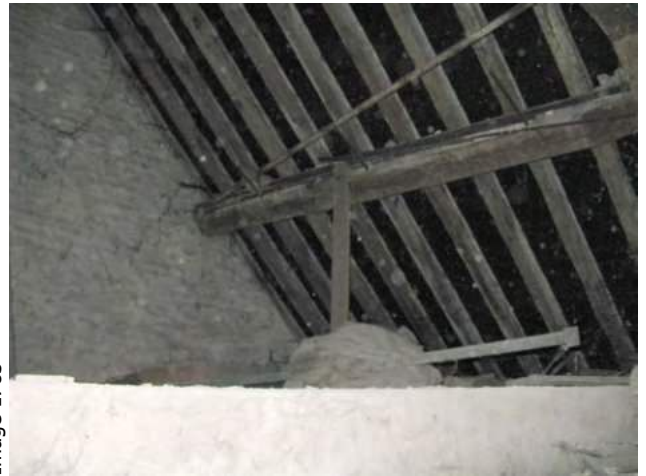
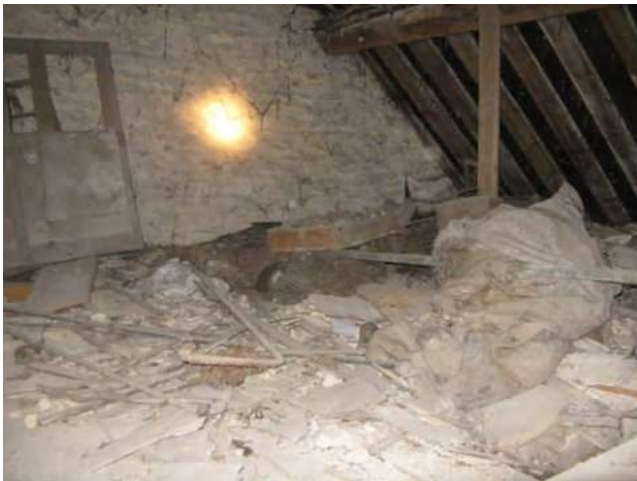
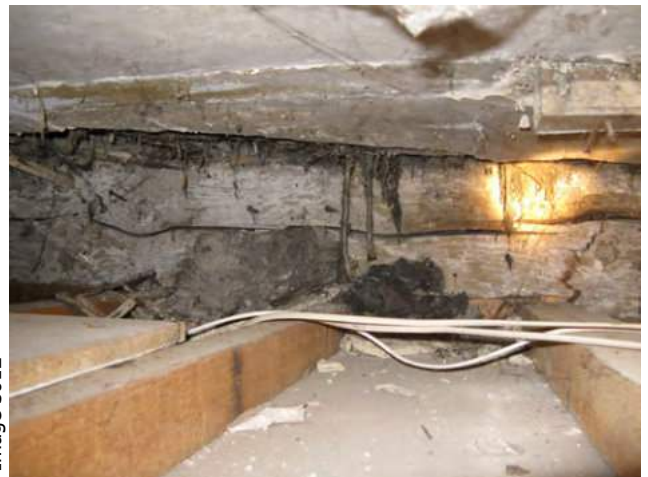
## Education Room roof space

**Views of the Education Room roof space. There is a false modern ceiling overlaying the original lath and plaster one. Light was seen coming through a pin-hole in the roof - there was no sign of water damage.**
