# **COMBE MILL**

## **Building Condition Report**

**August 2023**

Prepared for Combe Mill Society by Tony Simmons

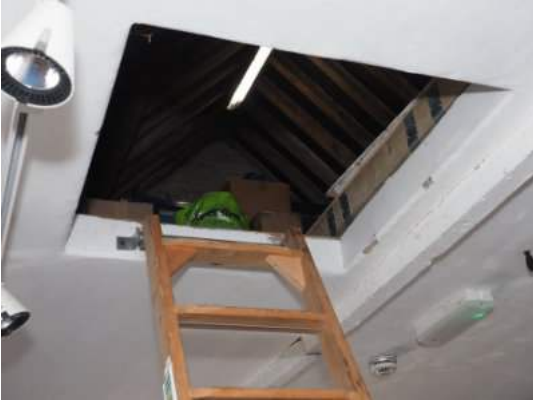
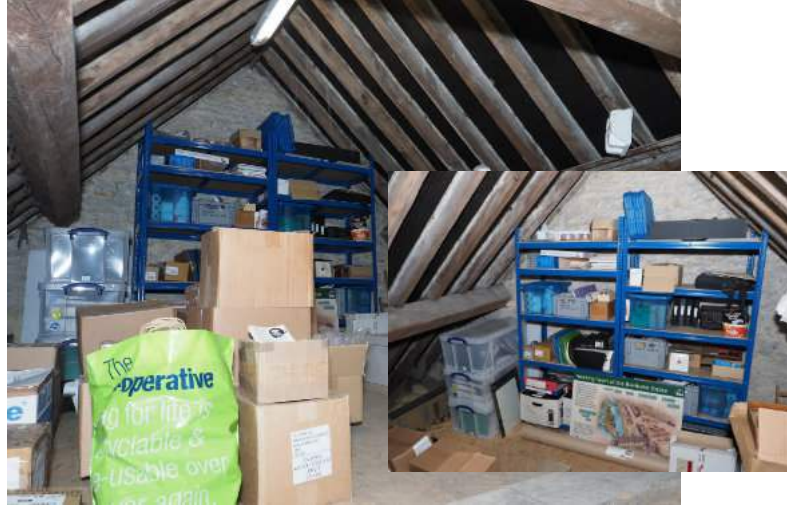
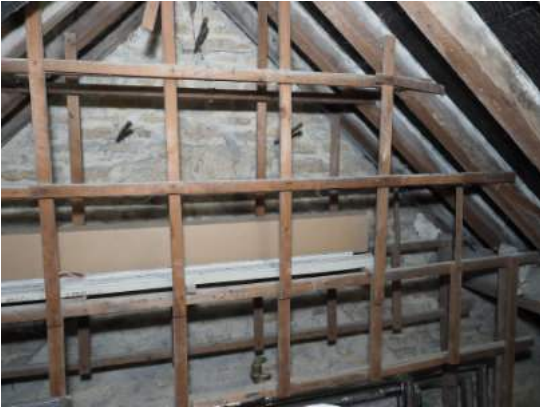
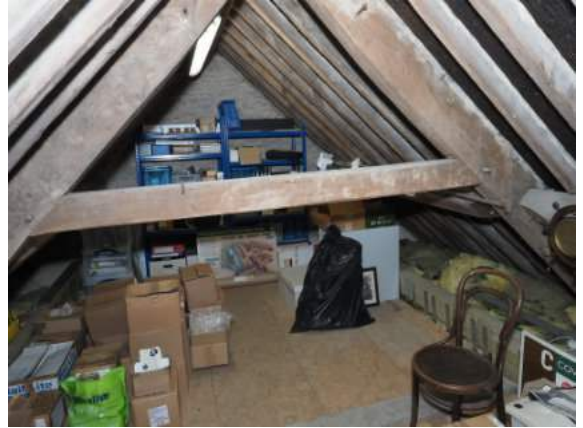
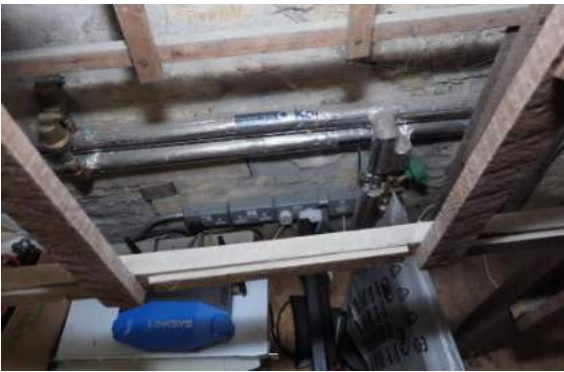
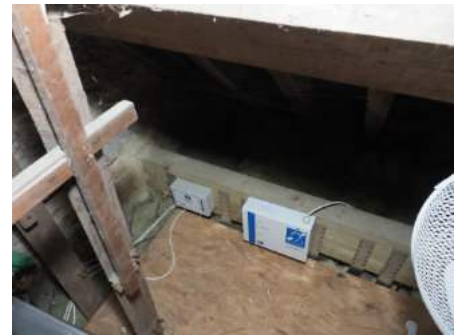
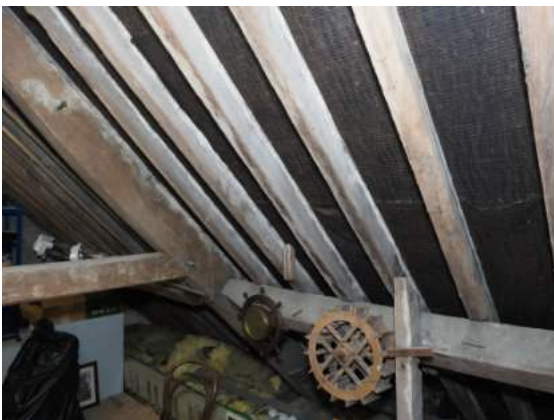
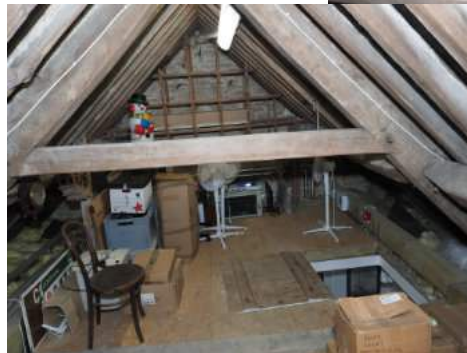
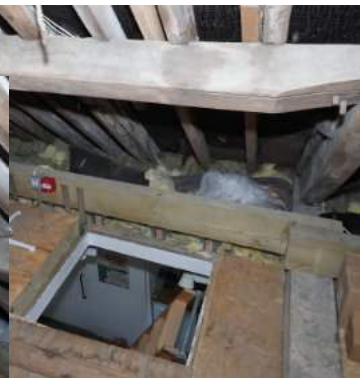
## Roof space reinforced, insulated and boarded
